# Access Compliance Report

## Public Rights-of-Way

### (Curb Ramps)

Intersection ID: 10020375		Main Street: BALLANTYNE CORPORATE PCross Street: N/A		Location: NE					
ADA ID: 911966D016C5		Ramp Type: Perp		Initial Pass/Fail: Fail		Overall Compliance: No		Severity Score: 1.25	
Codes/Mitigation Info/Possible Solution					Field Measurements/Component Compliance

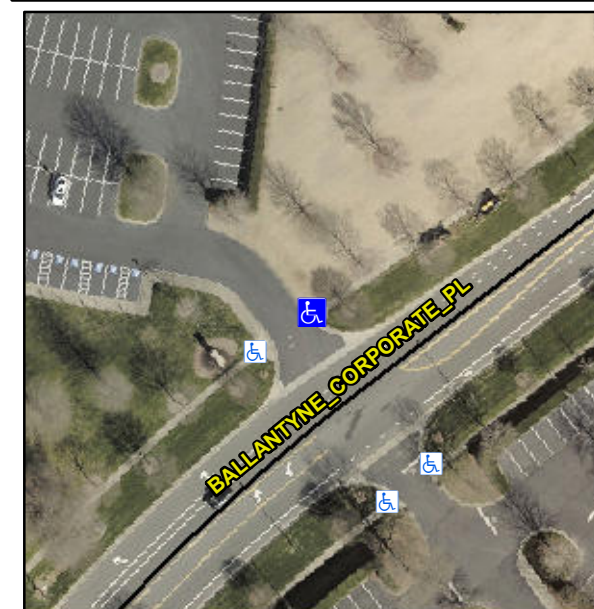
Compliance	Description	Data	Compliance	Description	Data
N/A	Ramp Length (in)	102.0	Yes	Ramp Slope (%)	6.7
Yes	Ramp Width (in)	48.0	No	Ramp XSlope (%)	3.1
N/A	Flare Type LT	N/A	N/A	Flare Type RT	N/A
N/A	Flare Slope LT (%)	N/A	N/A	Flare Slope RT (%)	N/A
N/A	Flare Traversable LT?	N/A	N/A	Flare Traversable RT?	N/A
N/A	Landing Length (in)	N/A	N/A	DWS Provided?	N/A
N/A	Landing Width (in)	N/A	N/A	DWS Contrast?	N/A
N/A	Landing Slope (%)	N/A	N/A	DWS Length (in)	N/A
N/A	Landing X Slope (%)	N/A	N/A	DWS Full Width?	N/A
N/A	Landing Curb? (Y/N)	N/A	N/A	DWS Offset (in)	N/A
N/A	Shared Landing?	N/A			
N/A	Gutter Ponding?	N/A	N/A	Gutter Slope (%)	N/A
N/A	Gutter Lip Ht (in)	N/A	N/A	Gutter X Slope (%)	N/A
N/A	Painted X Walk1?	No	N/A	Painted X Walk2?	N/A
	X Walk 1 Direction	To SW		X Walk 2 Direction	N/A
N/A	X Walk 1 Width (in)	N/A	N/A	X Walk 2 Width (in)	N/A
	X Walk 1 Slope (%)	3.3		X Walk 2 Slope (%)	N/A
	X Walk 1 X Slope (%)	1.1		X Walk 2 X Slope (%)	N/A

N/A	Ramp inside XWalk1?	N/A	N/A	Ramp inside XWalk2?	N/A
	Road Slope (%)	N/A	N/A	Clear Space?	N/A
	Road X Slope (%)	N/A	N/A	Clear Space to XWalk (in)	N/A
N/A	Any Obstructions?	N/A	N/A	Storm Grate/Utility Hazard?	N/A
	Obstruction Type			Storm Grate/Utility Type	
		N/A			N/A
			Yes	Surface Condition? (G/P)	Good

Possible Solutions:

**Remove & Replace Entire Ramp.**

PROW/ADA:

**R304.5.3**
