# Access Compliance Report

## Public Rights-of-Way

### (Curb Ramps)

Intersection ID: 10022444	Main Street: CANMORE_ST	Cross Street: N/A	Location: SE
ADA ID: 911C73E6CB0E	Ramp Type: Perp	Initial Pass/Fail: Fail	Overall Compliance: No
		Severity Score: 10

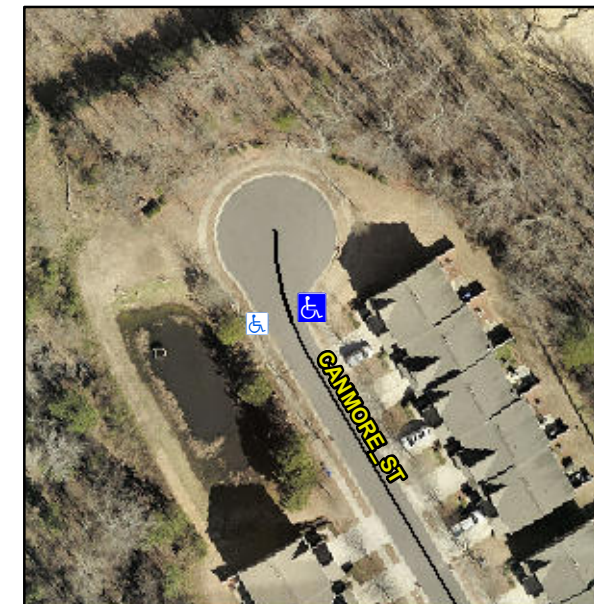
**Not Found, R304.5.1, R304.5.3**

Compliance	Description	Data	Compliance	Description	Data
N/A	Ramp Length (in)	47.0	Yes	Ramp Slope (%)	5.6
No	Ramp Width (in)	47.0	No	Ramp XSlope (%)	3.6
N/A	Flare Type LT	N/A	N/A	Flare Type RT	N/A
N/A	Flare Slope LT (%)	N/A	N/A	Flare Slope RT (%)	N/A
N/A	Flare Traversable LT?	N/A	N/A	Flare Traversable RT?	N/A
N/A	Landing Length (in)	N/A	N/A	DWS Provided?	N/A
N/A	Landing Width (in)	N/A	N/A	DWS Contrast?	N/A
N/A	Landing Slope (%)	N/A	N/A	DWS Length (in)	N/A
N/A	Landing X Slope (%)	N/A	N/A	DWS Full Width?	N/A
N/A	Landing Curb? (Y/N)	N/A	N/A	DWS Offset (in)	N/A
N/A	Shared Landing?	N/A			
N/A	Gutter Ponding?	N/A	N/A	Gutter Slope (%)	N/A
N/A	Gutter Lip Ht (in)	N/A	N/A	Gutter X Slope (%)	N/A
N/A	Painted X Walk1?	No	N/A	Painted X Walk2?	N/A
	X Walk 1 Direction	To W		X Walk 2 Direction	N/A
N/A	X Walk 1 Width (in)	N/A	N/A	X Walk 2 Width (in)	N/A
	X Walk 1 Slope (%)	3.2		X Walk 2 Slope (%)	N/A
	X Walk 1 X Slope (%)	0.1		X Walk 2 X Slope (%)	N/A

N/A	Ramp inside XWalk1?	N/A	N/A	Ramp inside XWalk2?	N/A
	Road Slope (%)	N/A	N/A	Clear Space?	N/A
	Road X Slope (%)	N/A	N/A	Clear Space to XWalk (in)	N/A
N/A	Any Obstructions?	N/A	N/A	Storm Grate/Utility Hazard?	N/A
	Obstruction Type			Storm Grate/Utility Type	
		N/A			N/A
			Yes	Surface Condition? (G/P)	Good

**Remove & Replace Entire Ramp.**

Total Cost: \$ 1850.00
