Access Compliance Report

Public Rights-of-Way

(Curb Ramps)

Intersection ID: 10779	Main Street: AVIDXCHANGE_LN	Cross Street: HAMILTON_ST	Location: SW
ADA ID: 911C9E410489	Ramp Type: Perp	Initial Pass/Fail: Fail	Overall Compliance: No
			Severity Score: 13.75

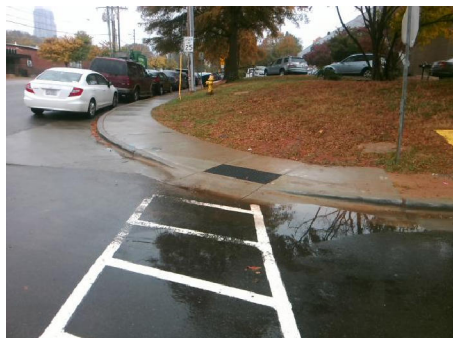
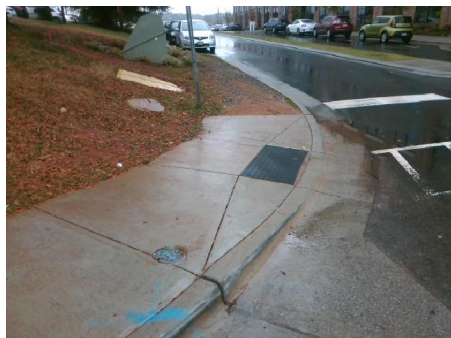
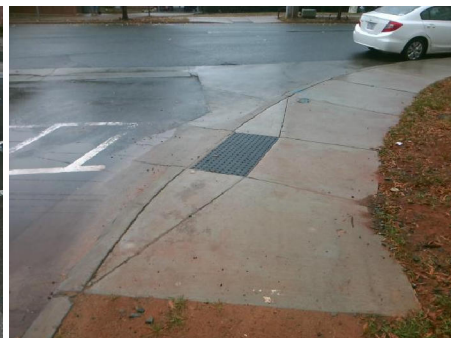
Possible Solutions:		Compliance	Description	Data	Compliance	Description	Data
	Remove & Replace Entire Ramp.		N/A	Ramp Length (in)	72.0	No	Ramp Slope (%)	9.1
			Yes	Ramp Width (in)	48.0	No	Ramp XSlope (%)	2.3
			N/A	Flare Type LT	N/A	N/A	Flare Type RT	N/A
			N/A	Flare Slope LT (%)	N/A	N/A	Flare Slope RT (%)	N/A
			N/A	Flare Traversable LT?	N/A	N/A	Flare Traversable RT?	N/A
			N/A	Landing Length (in)	N/A	N/A	DWS Provided?	N/A
			N/A	Landing Width (in)	N/A	N/A	DWS Contrast?	N/A
			N/A	Landing Slope (%)	N/A	N/A	DWS Length (in)	N/A
			N/A	Landing X Slope (%)	N/A	N/A	DWS Full Width?	N/A
Surveyor Notes:			N/A	Landing Curb? (Y/N)	N/A	N/A	DWS Offset (in)	N/A
PROW/ADA:			N/A	Shared Landing?	N/A			
R304.2.2, R304.5.3			N/A	Gutter Ponding?	N/A	N/A	Gutter Slope (%)	N/A
			N/A	Gutter Lip Ht (in)	N/A	N/A	Gutter X Slope (%)	N/A
			N/A	Painted X Walk1?	Yes	N/A	Painted X Walk2?	N/A

X Walk 1 Direction	To N		X Walk 2 Direction	N/A
			N/A	X Walk 1 Width (in)	52.0	N/A	X Walk 2 Width (in)	N/A
				X Walk 1 Slope (%)	0.7		X Walk 2 Slope (%)	N/A
				X Walk 1 X Slope (%)	1.2		X Walk 2 X Slope (%)	N/A
			N/A	Ramp inside XWalk1?	Yes	N/A	Ramp inside XWalk2?	N/A
				Road Slope (%)	N/A	N/A	Clear Space?	N/A
				Road X Slope (%)	N/A	N/A	Clear Space to XWalk (in)	N/A
			N/A	Any Obstructions?	N/A	N/A	Storm Grate/Utility Hazard?	N/A
				Obstruction Type			Storm Grate/Utility Type	
						N/A		N/A
						Yes	Surface Condition? (G/P)	Good
Total Cost:		\$ 1850.00						
Street 1 Name			AVIDXCHANGE LN					
Stop Condition-Street 2			StopSign					
Street 2 Name			N/A					
Stop Condition-Street 1			N/A
