Access Compliance Report

Public Rights-of-Way

(Curb Ramps)

Intersection ID: 24436	Main Street: CARMEL_RD	Cross Street: WINGEDFOOT_RD	Location: SW
ADA ID: 91293222C725	Ramp Type: PerpDiag	Initial Pass/Fail: Fail	Overall Compliance: No
		Severity Score: 22.5

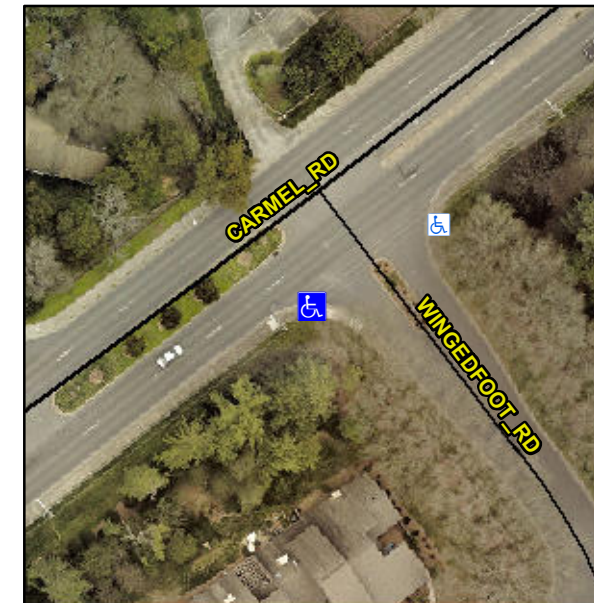
Not Found, R304.5.1, R304.2.2, R304.5.3

Compliance	Description	Data	Compliance	Description	Data
N/A	Ramp Length (in)	60.0	No	Ramp Slope (%)	10.8
No	Ramp Width (in)	39.0	No	Ramp XSlope (%)	3.5
N/A	Flare Type LT	N/A	N/A	Flare Type RT	N/A
N/A	Flare Slope LT (%)	N/A	N/A	Flare Slope RT (%)	N/A
N/A	Flare Traversable LT?	N/A	N/A	Flare Traversable RT?	N/A
N/A	Landing Length (in)	N/A	N/A	DWS Provided?	N/A
N/A	Landing Width (in)	N/A	N/A	DWS Contrast?	N/A
N/A	Landing Slope (%)	N/A	N/A	DWS Length (in)	N/A
N/A	Landing X Slope (%)	N/A	N/A	DWS Full Width?	N/A
N/A	Landing Curb? (Y/N)	N/A	N/A	DWS Offset (in)	N/A
N/A	Shared Landing?	N/A			
N/A	Gutter Ponding?	N/A	N/A	Gutter Slope (%)	N/A
N/A	Gutter Lip Ht (in)	N/A	N/A	Gutter X Slope (%)	N/A
N/A	Painted X Walk1?	No	N/A	Painted X Walk2?	No
	X Walk 1 Direction	To NE		X Walk 2 Direction	To N
N/A	X Walk 1 Width (in)	N/A	N/A	X Walk 2 Width (in)	N/A
	X Walk 1 Slope (%)	0.0		X Walk 2 Slope (%)	3.3
	X Walk 1 X Slope (%)	3.0		X Walk 2 X Slope (%)	0.3

N/A	Ramp inside XWalk1?	N/A	N/A	Ramp inside XWalk2?	N/A
	Road Slope (%)	2.6	N/A	Clear Space?	N/A
	Road X Slope (%)	2.5	N/A	Clear Space to XWalk (in)	N/A
N/A	Any Obstructions?	N/A	N/A	Storm Grate/Utility Hazard?	N/A
	Obstruction Type			Storm Grate/Utility Type	
		N/A			N/A
			Yes	Surface Condition? (G/P)	Good

Remove & Replace Curb Ramp With Two New Directional Ramps or Equivalent.
