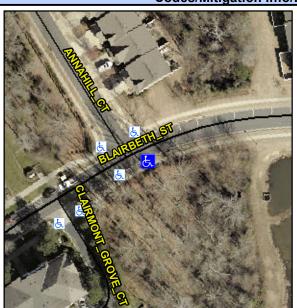
Intersection ID: 50945 Main Street: ANNAHILL_CT **Cross Street: BLAIRBETH_ST** Location: SE **Overall Compliance: No** ADA ID: 9133FF1C7D24 Ramp Type: Perp Initial Pass/Fail: Fail Severity Score: 33.75

Field Measurements/Component Compliance									
Compli	iance Description	Data	Compli	ance	Description	Data			
N/A	Ramp Length (in)	55.5	No	Ramp	Slope (%)	12.9			
No	Ramp Width (in)	47.5	Yes	Ramp	XSlope (%)	8.0			
N/A	Flare Type LT	N/A	N/A	Flare	Type RT	N/A			
N/A	Flare Slope LT (%)	N/A	N/A	Flare	Slope RT (%)	N/A			
N/A	Flare Traversable LT?	N/A	N/A	Flare	Traversable RT?	N/A			
N/A	Landing Length (in)	N/A	N/A	DWS	Provided?	N/A			
N/A	Landing Width (in)	N/A	N/A	DWS	Contrast?	N/A			
N/A	Landing Slope (%)	N/A	N/A	DWS	Length (in)	N/A			
N/A	Landing X Slope (%)	N/A	N/A	DWS	Full Width?	N/A			
N/A	Landing Curb? (Y/N)	N/A	N/A	DWS	Offset (in)	N/A			
N/A	Shared Landing?	N/A							
N/A	Gutter Ponding?	N/A	N/A	Gutte	r Slope (%)	N/A			
N/A	Gutter Lip Ht (in)	N/A	N/A	Gutte	r X Slope (%)	N/A			
N/A	Painted X Walk1?	No	N/A	Painte	ed X Walk2?	N/A			
	X Walk 1 Direction	To NW		X Wa	lk 2 Direction	N/A			
N/A	X Walk 1 Width (in)	N/A	N/A	X Wa	lk 2 Width (in)	N/A

Possible Solutions: Remove & Replace Entire Ramp. Surveyor Notes: N/A PROW/ADA: Not Found, R304.5.1, R304.2.2
