Access Compliance Report

Public Rights-of-Way

(Curb Ramps)

| Intersection ID: 46788 | Main Street: STOWE_ACRES_DR | Cross Street: ALMOND_HILLS_DR | Location: SW |

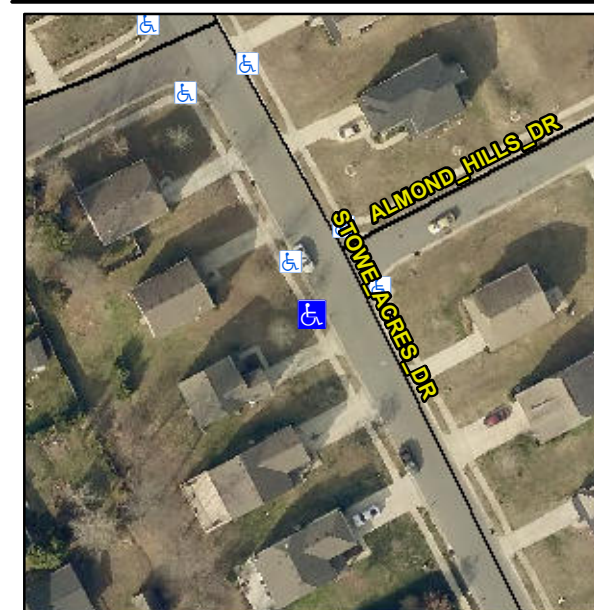
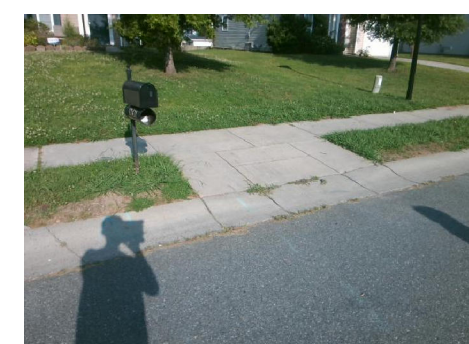
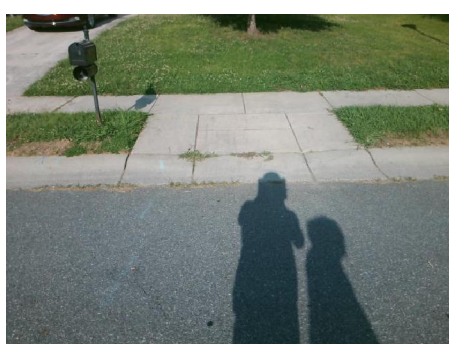
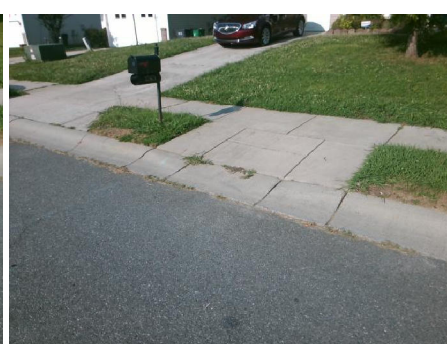
| ADA ID: 913DA4E035C9 | Ramp Type: Perp | Initial Pass/Fail: Fail | Overall Compliance: No |

| Severity Score: 13.75 | | | |

Not Found, R304.2.2, R304.5.3

| Compliance | Description | Data | Compliance | Description | Data |
|---|---|---|---|---|---|
| N/A | Ramp Length (in) | 47.5 | No | Ramp Slope (%) | 10.5 |
| Yes | Ramp Width (in) | 48.0 | No | Ramp XSlope (%) | 2.9 |

Remove & Replace Entire Ramp.
