Access Compliance Report

Public Rights-of-Way

(Curb Ramps)

Intersection ID: 31372	Main Street: GREENWAY_VISTA_LN	Cross Street: MCINTYRE_RIDGE_DR	Location: S
ADA ID: 914DC7999D7F	Ramp Type: BlendTrans1	Initial Pass/Fail: Fail	Overall Compliance: No
Severity Score: 10			
Codes/Mitigation Info/Possible Solution		Field Measurements/Component Compliance

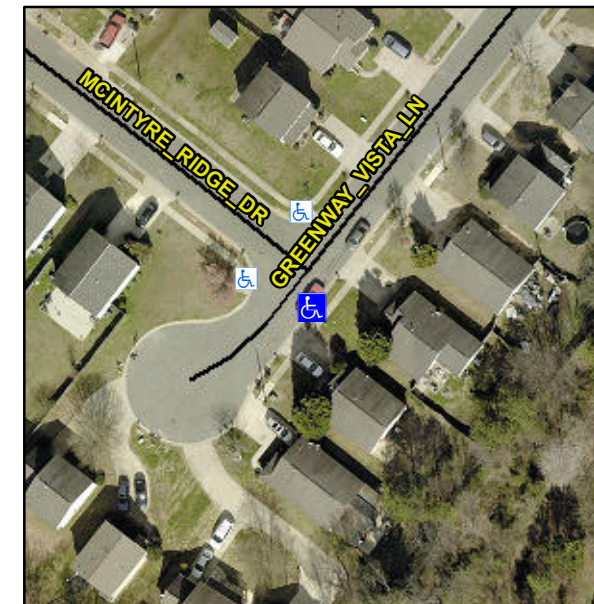
Not Found, R304.5.1, R304.5.3

Compliance	Description	Data	Compliance	Description	Data
N/A	Ramp Length (in)	47.5	Yes	BlendTrans Slope (%)	4.1
No	Ramp Width (in)	46.0	No	BlendTrans XSlope (%)	4.0
N/A	Flare Type LT	N/A	N/A	Flare Type RT	N/A
N/A	Flare Slope LT (%)	N/A	N/A	Flare Slope RT (%)	N/A
N/A	Flare Traversable LT?	N/A	N/A	Flare Traversable RT?	N/A
N/A	Landing Length (in)	N/A	N/A	DWS Provided?	N/A
N/A	Landing Width (in)	N/A	N/A	DWS Contrast?	N/A
N/A	Landing Slope (%)	N/A	N/A	DWS Length (in)	N/A
N/A	Landing X Slope (%)	N/A	N/A	DWS Full Width?	N/A
N/A	Landing Curb? (Y/N)	N/A	N/A	DWS Offset (in)	N/A
N/A	Shared Landing?	N/A			
N/A	Gutter Ponding?	N/A	N/A	Gutter Slope (%)	N/A
N/A	Gutter Lip Ht (in)	N/A	N/A	Gutter X Slope (%)	N/A
N/A	Painted X Walk1?	No	N/A	Painted X Walk2?	N/A
	X Walk 1 Direction	To NW		X Walk 2 Direction	N/A
	X Walk 1 Width (in)	N/A		X Walk 2 Width (in)	N/A
	X Walk 1 Slope (%)	3.4		X Walk 2 Slope (%)	N/A
	X Walk 1 X Slope (%)	3.6		X Walk 2 X Slope (%)	N/A

N/A	Ramp inside XWalk1?	N/A	N/A	Ramp inside XWalk2?	N/A
	Road Slope (%)	3.6		Clear Space?	N/A
	Road X Slope (%)	3.4	N/A	Clear Space to XWalk (in)	N/A
N/A	Any Obstructions?	N/A	N/A	Storm Grate/Utility Hazard?	N/A
	Obstruction Type			Storm Grate/Utility Type	
		N/A			N/A
			Yes	Surface Condition? (G/P)	Good
			No	Curb Slope (%)	11.6

Remove & Replace Curb Ramp With Two New Directional Ramps or Equivalent.
