# Access Compliance Report

## Public Rights-of-Way

### (Curb Ramps)

Intersection ID: 23385	Main Street: GLENEAGLES_RD	Cross Street: WINGED_BOURNE	Location: SE
ADA ID: 9152FFE0C3F9	Ramp Type: PerpDiag	Initial Pass/Fail: Fail	Overall Compliance: No
Codes/Mitigation Info/Possible Solution		Field Measurements/Component Compliance

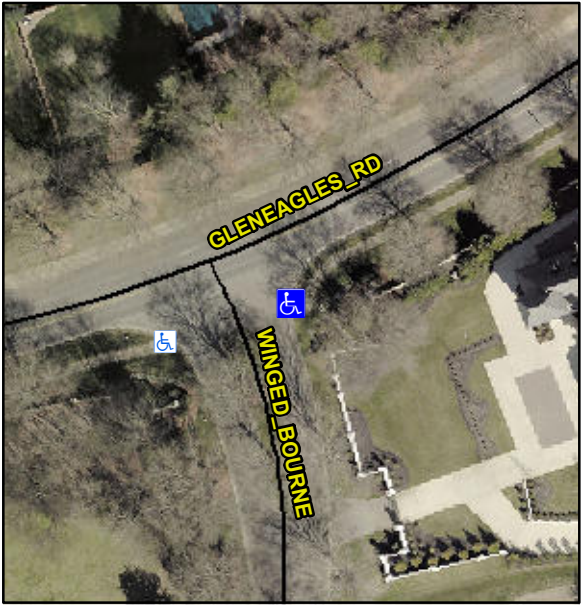
Possible Solutions:						
	Remove & Replace Curb Ramp With Two New Directional Ramps or Equivalent.						
	Surveyor Notes:						
	N/A						
	PROW/ADA:						
	Not Found, R304.5.1, R304.5.3						
Street 1 Name	GLENEAGLES RD	Compliance	Description	Data	Compliance	Description	Data
Stop Condition-Street 2	None	N/A	Ramp Length (in)	120.0	Yes	Ramp Slope (%)	6.5
Street 2 Name	WINGED BOURNE	No	Ramp Width (in)	43.0	No	Ramp XSlope (%)	3.4
Stop Condition-Street 1	StopSign	N/A	Flare Type LT	N/A	N/A	Flare Type RT	N/A
		N/A	Flare Slope LT (%)	N/A	N/A	Flare Slope RT (%)	N/A
		N/A	Flare Traversable LT?	N/A	N/A	Flare Traversable RT?	N/A
		N/A	Landing Length (in)	N/A	N/A	DWS Provided?	N/A
		N/A	Landing Width (in)	N/A	N/A	DWS Contrast?	N/A
		N/A	Landing Slope (%)	N/A	N/A	DWS Length (in)	N/A
		N/A	Landing X Slope (%)	N/A	N/A	DWS Full Width?	N/A
		N/A	Landing Curb? (Y/N)	N/A	N/A	DWS Offset (in)	N/A
		N/A	Shared Landing?	N/A
