Access Compliance Report

Public Rights-of-Way

(Curb Ramps)

Intersection ID: 17746	Main Street: BARWICK_RD	Cross Street: MERWICK_CR	Location: E
ADA ID: 915862F8B6F8	Ramp Type: PerpDiag	Initial Pass/Fail: Fail	Overall Compliance: No
Severity Score: 8.75			
Codes/Mitigation Info/Possible Solution		Field Measurements/Component Compliance

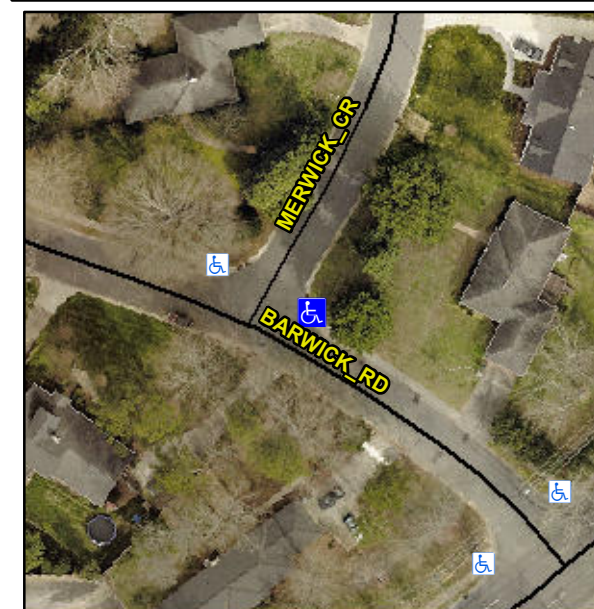
Not Found, R304.5.1

Compliance	Description	Data	Compliance	Description	Data
N/A	Ramp Length (in)	48.0	Yes	Ramp Slope (%)	7.4
No	Ramp Width (in)	43.0	Yes	Ramp XSlope (%)	0.7
N/A	Flare Type LT	N/A	N/A	Flare Type RT	N/A
N/A	Flare Slope LT (%)	N/A	N/A	Flare Slope RT (%)	N/A
N/A	Flare Traversable LT?	N/A	N/A	Flare Traversable RT?	N/A
N/A	Landing Length (in)	N/A	N/A	DWS Provided?	N/A
N/A	Landing Width (in)	N/A	N/A	DWS Contrast?	N/A
N/A	Landing Slope (%)	N/A	N/A	DWS Length (in)	N/A
N/A	Landing X Slope (%)	N/A	N/A	DWS Full Width?	N/A
N/A	Landing Curb? (Y/N)	N/A	N/A	DWS Offset (in)	N/A
N/A	Shared Landing?	N/A			
N/A	Gutter Ponding?	N/A	N/A	Gutter Slope (%)	N/A
N/A	Gutter Lip Ht (in)	N/A	N/A	Gutter X Slope (%)	N/A
N/A	Painted X Walk1?	No	N/A	Painted X Walk2?	No
	X Walk 1 Direction	To NW		X Walk 2 Direction	To SW
N/A	X Walk 1 Width (in)	N/A	N/A	X Walk 2 Width (in)	N/A
	X Walk 1 Slope (%)	4.0		X Walk 2 Slope (%)	7.0
	X Walk 1 X Slope (%)	4.9		X Walk 2 X Slope (%)	0.9

N/A	Ramp inside XWalk1?	N/A	N/A	Ramp inside XWalk2?	N/A
	Road Slope (%)	1.2	N/A	Clear Space?	N/A
	Road X Slope (%)	6.8	N/A	Clear Space to XWalk (in)	N/A
N/A	Any Obstructions?	N/A	N/A	Storm Grate/Utility Hazard?	N/A
	Obstruction Type			Storm Grate/Utility Type	
		N/A			N/A
			Yes	Surface Condition? (G/P)	Good

Remove & Replace Curb Ramp With Two New Directional Ramps or Equivalent.

Total Cost: \$ 3200.00
