Access Compliance Report

Public Rights-of-Way

(Curb Ramps)

Intersection ID: 11058	Main Street: N_I-77_EXIT_10B_RA	Cross Street: N_I-77_EXIT_10C_RA	Location: S
ADA ID: 916DEE795BD0	Ramp Type: Para	Initial Pass/Fail: Fail	Overall Compliance: No
Severity Score: 12.5			
Codes/Mitigation Info/Possible Solution		Field Measurements/Component Compliance

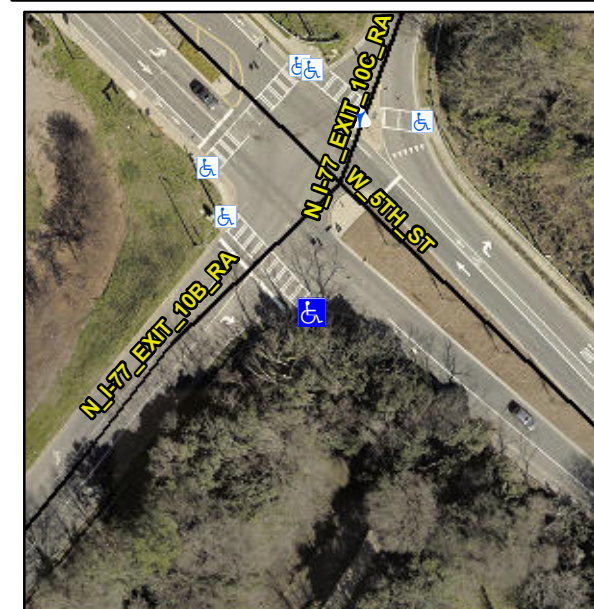
RT RP < 5%

Compliance	Description	Data	Compliance	Description	Data
N/A	Ramp Length LT (in)	84.0	N/A	Ramp Length RT (in)	64.0
Yes	Ramp Width LT (in)	62.0	Yes	Ramp Width RT (in)	62.0
No	Ramp Slope LT (%)	8.9	Yes	Ramp Slope RT (%)	4.3
Yes	Ramp XSlope LT (%)	0.4	Yes	Ramp XSlope RT (%)	1.5
N/A	Landing Length (in)	N/A	N/A	DWS Provided?	N/A
N/A	Landing Width (in)	N/A	N/A	DWS Contrast?	N/A
N/A	Landing Slope (%)	N/A	N/A	DWS Length (in)	N/A
N/A	Landing X Slope (%)	N/A	N/A	DWS Full Width?	N/A
N/A	Landing Curb? (Y/N)	N/A	N/A	DWS Offset (in)	N/A
N/A	Shared Landing?	N/A			
N/A	Gutter Ponding?	N/A	N/A	Gutter Slope (%)	N/A
N/A	Gutter Lip Ht (in)	N/A	N/A	Gutter X Slope (%)	N/A
N/A	Painted X Walk1?	Yes	N/A	Painted X Walk2?	N/A
	X Walk 1 Direction	To NW		X Walk 2 Direction	N/A
N/A	X Walk 1 Width (in)	110.0	N/A	X Walk 2 Width (in)	N/A
	X Walk 1 Slope (%)	2.1		X Walk 2 Slope (%)	N/A
	X Walk 1 X Slope (%)	5.0		X Walk 2 X Slope (%)	N/A
N/A	Ramp inside XWalk1?	Yes	N/A	Ramp inside XWalk2?	N/A

Road Slope (%)	N/A	N/A	Clear Space?	N/A
	Road X Slope (%)	N/A	N/A	Clear Space to XWalk (in)	N/A
N/A	Any Obstructions?	N/A	N/A	Storm Grate/Utility Hazard?	N/A
	Obstruction Type			Storm Grate/Utility Type	
		N/A			N/A
			Yes	Surface Condition? (G/P)	Good
			N/A	Curb Slope (%)	5.6

Possible Solutions:

Remove & Replace Entire Ramp.
