Access Compliance Report Public Rights-of-Way (Curb Ramps)

Intersection ID: 8320Main Street: JOHNSON_RDCross Street: N_GRAHAM_STLocation:SEADA ID: 9173C56BA40BRamp Type: PerpInitial Pass/Fail: FailOverall Compliance: NoSeverity Score:8.75

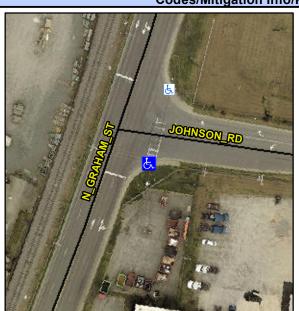
Field Measurements/Component Compliance								
Comp	liance Description	Data	Comp	liance Description	Data			
N/A	Ramp Length (in)	60.5	Yes	Ramp Slope (%)	6.5			
No	Ramp Width (in)	42.0	Yes	Ramp XSlope (%)	0.0			
N/A	Flare Type LT	N/A	N/A	Flare Type RT	N/A			
N/A	Flare Slope LT (%)	N/A	N/A	Flare Slope RT (%)	N/A			
N/A	Flare Traversable LT?	N/A	N/A	Flare Traversable RT?	N/A			
N/A	Landing Length (in)	N/A	N/A	DWS Provided?	N/A			
N/A	Landing Width (in)	N/A	N/A	DWS Contrast?	N/A			
N/A	Landing Slope (%)	N/A	N/A	DWS Length (in)	N/A			
N/A	Landing X Slope (%)	N/A	N/A	DWS Full Width?	N/A			
N/A	Landing Curb? (Y/N)	N/A	N/A	DWS Offset (in)	N/A			
N/A	Shared Landing?	N/A						
N/A	Gutter Ponding?	N/A	N/A	Gutter Slope (%)	N/A			
N/A	Gutter Lip Ht (in)	1.0	N/A	Gutter X Slope (%)	N/A			
N/A	Painted X Walk1?	Yes	N/A	Painted X Walk2?	N/A			
	X Walk 1 Direction	To NE		X Walk 2 Direction	N/A			
N/A	X Walk 1 Width (in)	104.0	N/A	X Walk 2 Width (in)	N/A

X Walk 1 Slope (%)	2.4		X Walk 2 Slope (%)	N/A			
	X Walk 1 X Slope (%)	1.6		X Walk 2 X Slope (%)	N/A			
N/A	Ramp inside XWalk1?	Yes	N/A	Ramp inside XWalk2?	N/A			
	Road Slope (%)	N/A	N/A	Clear Space?	N/A			
	Road X Slope (%)	N/A	N/A	Clear Space to XWalk (in)	N/A			
N/A	Any Obstructions?	N/A	N/A	Storm Grate/Utility Hazard?	N/A			
	Obstruction Type		l	Storm Grate/Utility Type				
		N/A			N/A			
			Yes	Surface Condition? (G/P)	Good

1	rossible solution	
THE PERSON NAMED IN	Possible Solutions:	Comp
	Remove & Replace Entire Ramp.	N/A
		No
		N/A
	Surveyor Notes:	N/A
	N/A	N/A
		N/A
		N/A
		N/A
	PROW/ADA:	N/A
	Not Found, R304.5.1	N/A
		N/A
1		N/A
		N/A
