Intersection ID: 29920	Main Street: NORTHRIDGE_DR	Cross Street: WYNDHAM_HILL_DR	Location:	NW
ADA ID: 917B181CE4EC	Ramp Type: PerpDiag	Initial Pass/Fail: Fail	Overall Compliance: No	Severity Score: 33.75

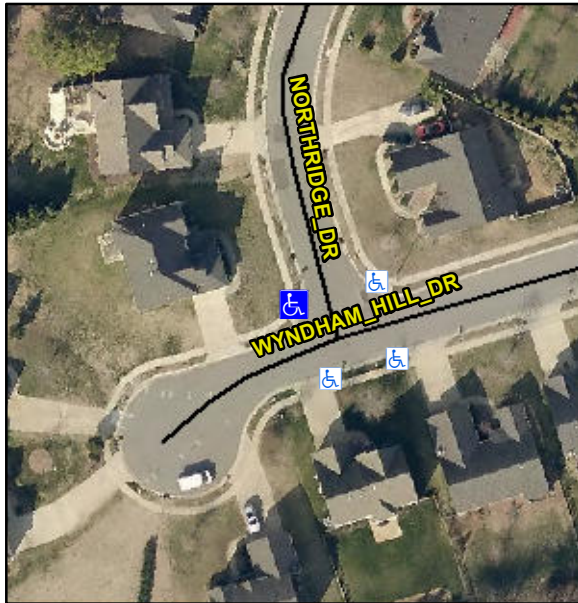
**Not Found, R304.5.1, R304.2.2,
R304.5.3**

Compliance	Description	Data	Compliance	Description	Data
N/A	Ramp Length (in)	48.0	No	Ramp Slope (%)	8.5
No	Ramp Width (in)	43.0	No	Ramp XSlope (%)	5.1
N/A	Flare Type LT	N/A	N/A	Flare Type RT	N/A
N/A	Flare Slope LT (%)	N/A	N/A	Flare Slope RT (%)	N/A
N/A	Flare Traversable LT?	N/A	N/A	Flare Traversable RT?	N/A
N/A	Landing Length (in)	N/A	N/A	DWS Provided?	N/A
N/A	Landing Width (in)	N/A	N/A	DWS Contrast?	N/A
N/A	Landing Slope (%)	N/A	N/A	DWS Length (in)	N/A
N/A	Landing X Slope (%)	N/A	N/A	DWS Full Width?	N/A
N/A	Landing Curb? (Y/N)	N/A	N/A	DWS Offset (in)	N/A
N/A	Shared Landing?	N/A			
N/A	Gutter Ponding?	N/A	N/A	Gutter Slope (%)	N/A
N/A	Gutter Lip Ht (in)	N/A	N/A	Gutter X Slope (%)	N/A
N/A	Painted X Walk1?	No	N/A	Painted X Walk2?	No
	X Walk 1 Direction	To S		X Walk 2 Direction	To E
N/A	X Walk 1 Width (in)	N/A	N/A	X Walk 2 Width (in)	N/A
	X Walk 1 Slope (%)	4.2		X Walk 2 Slope (%)	0.0
	X Walk 1 X Slope (%)	4.8		X Walk 2 X Slope (%)	2.3

N/A	Ramp inside XWalk1?	N/A	N/A	Ramp inside XWalk2?	N/A
	Road Slope (%)	3.9	N/A	Clear Space?	N/A
	Road X Slope (%)	0.5	N/A	Clear Space to XWalk (in)	N/A
N/A	Any Obstructions?	N/A	N/A	Storm Grate/Utility Hazard?	N/A
	Obstruction Type			Storm Grate/Utility Type	
		N/A			N/A
			Yes	Surface Condition? (G/P)	Good

Possible Solutions:

Remove & Replace Curb Ramp With Two New Directional Ramps or Equivalent.

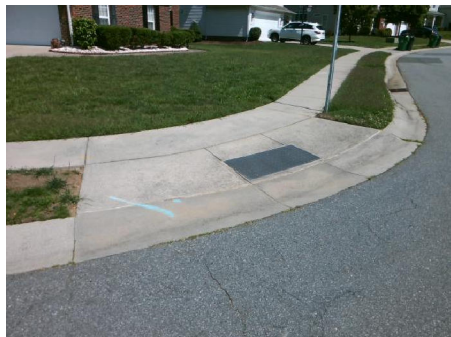
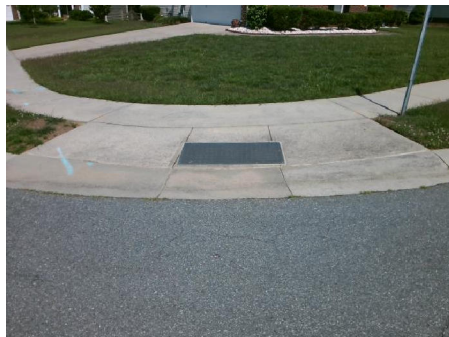
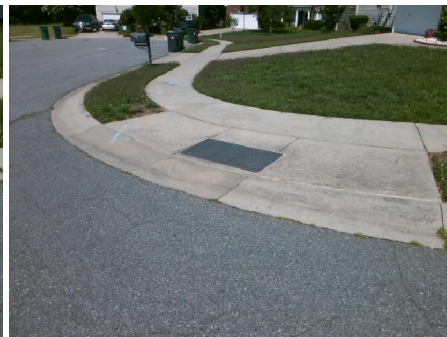
Street 1 Name	WYNDHAM HILL DR
Stop Condition-Street 2	None
Street 2 Name	NORTHRIDGE DR
Stop Condition-Street 1	StopSign
