Access Compliance Report

Public Rights-of-Way

(Curb Ramps)

Intersection ID: 44115	Main Street: RUTHERGLEN_CT	Cross Street: RIDING_HILL_AV	Location: NE
ADA ID: 9184C9EE4793	Ramp Type: BlendTrans1	Initial Pass/Fail: Fail	Overall Compliance: No
		Severity Score: 8.75

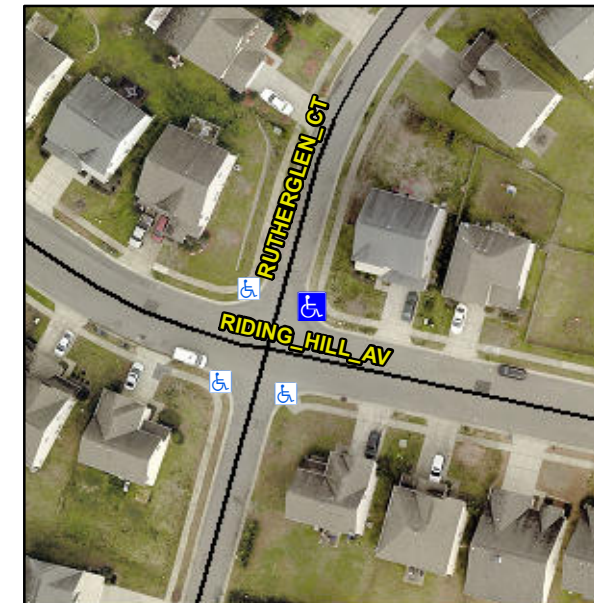
Not Found, R304.5.1

Compliance	Description	Data	Compliance	Description	Data
N/A	Ramp Length (in)	51.0	Yes	BlendTrans Slope (%)	2.5
No	Ramp Width (in)	42.0	Yes	BlendTrans XSlope (%)	0.1
N/A	Flare Type LT	N/A	N/A	Flare Type RT	N/A
N/A	Flare Slope LT (%)	N/A	N/A	Flare Slope RT (%)	N/A
N/A	Flare Traversable LT?	N/A	N/A	Flare Traversable RT?	N/A
N/A	Landing Length (in)	N/A	N/A	DWS Provided?	N/A
N/A	Landing Width (in)	N/A	N/A	DWS Contrast?	N/A
N/A	Landing Slope (%)	N/A	N/A	DWS Length (in)	N/A
N/A	Landing X Slope (%)	N/A	N/A	DWS Full Width?	N/A
N/A	Landing Curb? (Y/N)	N/A	N/A	DWS Offset (in)	N/A
N/A	Shared Landing?	N/A			
N/A	Gutter Ponding?	N/A	N/A	Gutter Slope (%)	N/A
N/A	Gutter Lip Ht (in)	N/A	N/A	Gutter X Slope (%)	N/A
N/A	Painted X Walk1?	No	N/A	Painted X Walk2?	No
	X Walk 1 Direction	To NW		X Walk 2 Direction	To SW
	X Walk 1 Width (in)	N/A		X Walk 2 Width (in)	N/A
	X Walk 1 Slope (%)	7.0		X Walk 2 Slope (%)	4.8
	X Walk 1 X Slope (%)	2.2		X Walk 2 X Slope (%)	5.3

N/A	Ramp inside XWalk1?	N/A	N/A	Ramp inside XWalk2?	N/A
	Road Slope (%)	0.1		Clear Space?	N/A
	Road X Slope (%)	7.3	N/A	Clear Space to XWalk (in)	N/A
N/A	Any Obstructions?	N/A	N/A	Storm Grate/Utility Hazard?	N/A
	Obstruction Type			Storm Grate/Utility Type	
		N/A			N/A
			Yes	Surface Condition? (G/P)	Good
			No	Curb Slope (%)	8.5

Remove & Replace Curb Ramp With Two New Directional Ramps or Equivalent.
