# Access Compliance Report

## Public Rights-of-Way

Intersection ID: 14071	Main Street: CLEVELAND_AV	Cross Street: E_KINGSTON_AV	Location: E
ADA ID: 918C5B5CDA6D	Ramp Type: Directional1	Initial Pass/Fail: Fail	Overall Compliance: No
			Severity Score: 13.75

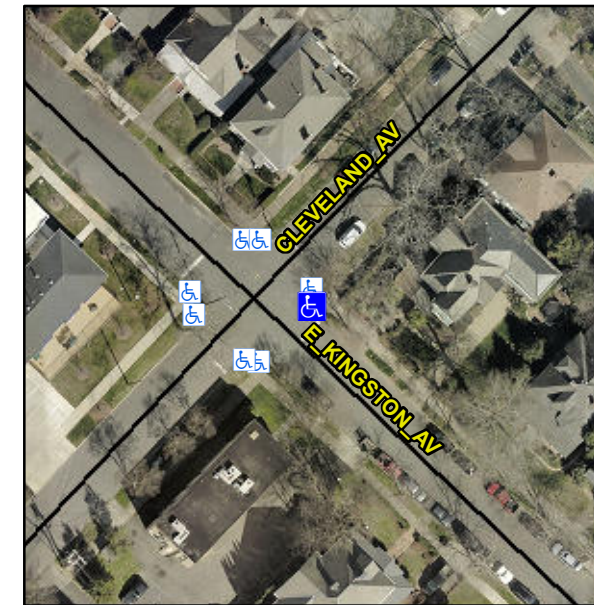
**NO CURB LINE, ASP LIP 1.0"**

**R304.2.2, R304.5.3**

Compliance	Description	Data	Compliance	Description	Data
N/A	Ramp Length (in)	60.0	N/A	Grade Break?	N/A
Yes	Ramp Width (in)	84.0	N/A	Grade Break Slope (%)	0.0
No	Ramp Slope (%)	9.9	N/A	Grade Break XSlope (%)	0.0
No	Ramp XSlope (%)	2.2			
N/A	Flare Type LT	N/A	N/A	Flare Type RT	N/A
N/A	Flare Slope LT (%)	N/A	N/A	Flare Slope RT (%)	0.0
N/A	Flare Traversable LT?	N/A	N/A	Flare Traversable RT?	N/A
N/A	Landing Length (in)	0.0	N/A	DWS Provided?	N/A
N/A	Landing Width (in)	0.0	N/A	DWS Contrast?	N/A
N/A	Landing Slope (%)	0.0	N/A	DWS Length (in)	N/A
N/A	Landing X Slope (%)	0.0	N/A	DWS Full Width?	N/A
N/A	Landing Curb? (Y/N)	N/A	N/A	DWS Offset LT (in)	N/A
N/A	Shared Landing?	N/A	N/A	DWS Offset RT (in)	N/A
N/A	Gutter Ponding?	0.0	N/A	Gutter Slope (%)	N/A
N/A	Gutter Lip Ht (in)	0.0	N/A	Gutter X Slope (%)	N/A
N/A	Painted X Walk1?	No		Road Slope (%)	5.1
	X Walk 1 Direction	To SW		Road X Slope (%)	2.7
	X Walk 1 Width (in)	N/A		Clear Space?	N/A

**Remove & Replace Entire Ramp.**
