# Access Compliance Report

## Public Rights-of-Way

### (Curb Ramps)

| Intersection ID: 31934 | Main Street: STEELE_CREEK_RD | Cross Street: BRANCH_BEND_LN | Location: SW |

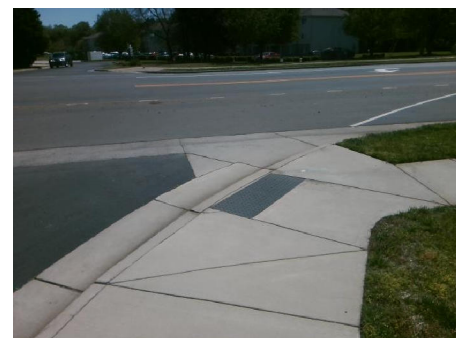
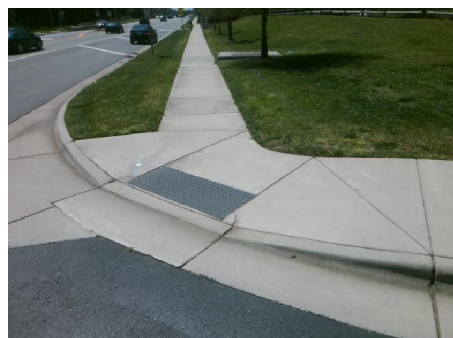
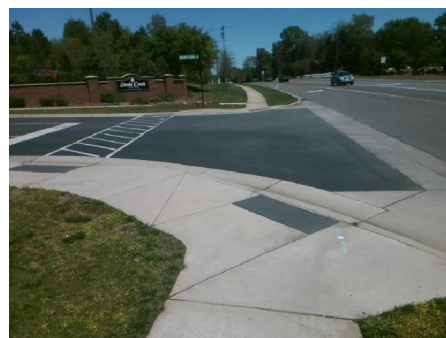
| ADA ID: 9195231D99DD | Ramp Type: BlendTrans2 | Initial Pass/Fail: Fail | Overall Compliance: No |
| Severity Score: 12.5 | | | |

| Compliance | Description | Data | Compliance | Description | Data |
|---|---|---|---|---|---|
| Yes | Ramp Width (in) | 60.0 | No | BlendTrans XSlope (%) | 5.1 |

**Remove & Replace Curb Ramp With Two New Directional Ramps or Equivalent.**

**R304.5.3**

Total Cost: \$ 3200.00
