# Access Compliance Report

## Public Rights-of-Way (Curb Ramps)

Intersection ID: 31771	Main Street: STARNES RANDALL RD	Cross Street: PINYON PINE LN	Location: NE
ADA ID: 91A785C7CBB3	Ramp Type: Perp	Initial Pass/Fail: Fail	Overall Compliance: No
Severity Score: 25			
Codes/Mitigation Info/Possible Solution		Field Measurements/Component Compliance

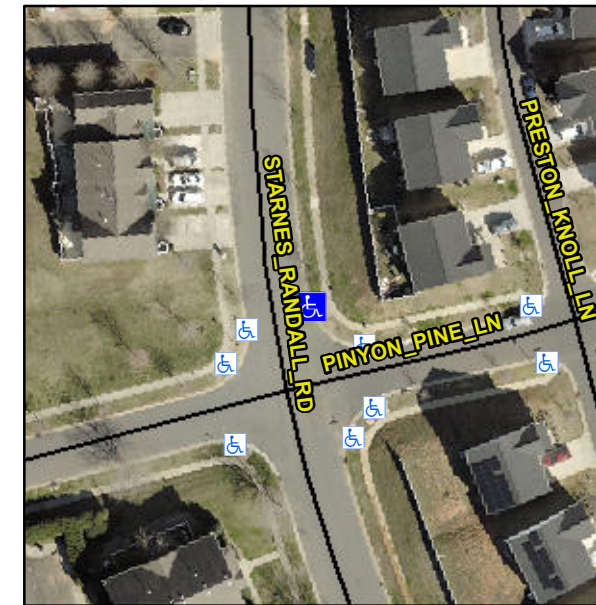
Compliance	Description	Data	Compliance	Description	Data
N/A	Ramp Length (in)	82.0	No	Ramp Slope (%)	9.8
Yes	Ramp Width (in)	53.0	No	Ramp XSlope (%)	5.3
N/A	Flare Type LT	N/A	N/A	Flare Type RT	N/A
N/A	Flare Slope LT (%)	N/A	N/A	Flare Slope RT (%)	N/A
N/A	Flare Traversable LT?	N/A	N/A	Flare Traversable RT?	N/A
N/A	Landing Length (in)	N/A	N/A	DWS Provided?	N/A
N/A	Landing Width (in)	N/A	N/A	DWS Contrast?	N/A
N/A	Landing Slope (%)	N/A	N/A	DWS Length (in)	N/A
N/A	Landing X Slope (%)	N/A	N/A	DWS Full Width?	N/A
N/A	Landing Curb? (Y/N)	N/A	N/A	DWS Offset (in)	N/A
N/A	Shared Landing?	N/A			
N/A	Gutter Ponding?	N/A	N/A	Gutter Slope (%)	N/A
N/A	Gutter Lip Ht (in)	N/A	N/A	Gutter X Slope (%)	N/A
N/A	Painted X Walk1?	No	N/A	Painted X Walk2?	N/A
	X Walk 1 Direction	To W		X Walk 2 Direction	N/A
N/A	X Walk 1 Width (in)	N/A	N/A	X Walk 2 Width (in)	N/A
	X Walk 1 Slope (%)	3.3		X Walk 2 Slope (%)	N/A
	X Walk 1 X Slope (%)	2.0		X Walk 2 X Slope (%)	N/A

N/A	Ramp inside XWalk1?	N/A	N/A	Ramp inside XWalk2?	N/A
	Road Slope (%)	N/A	N/A	Clear Space?	N/A
	Road X Slope (%)	N/A	N/A	Clear Space to XWalk (in)	N/A
N/A	Any Obstructions?	N/A	N/A	Storm Grate/Utility Hazard?	N/A
	Obstruction Type			Storm Grate/Utility Type	
		N/A			N/A
			Yes	Surface Condition? (G/P)	Good

**Remove & Replace Entire Ramp.**

**R304.2.2, R304.5.3**
