Access Compliance Report

Public Rights-of-Way

(Curb Ramps)

Intersection ID: 17746	Main Street: BARWICK_RD	Cross Street: MERWICK_CR	Location: N
ADA ID: 91B20F2C508D	Ramp Type: Directional1	Initial Pass/Fail: Fail	Overall Compliance: No
			Severity Score: 21.25

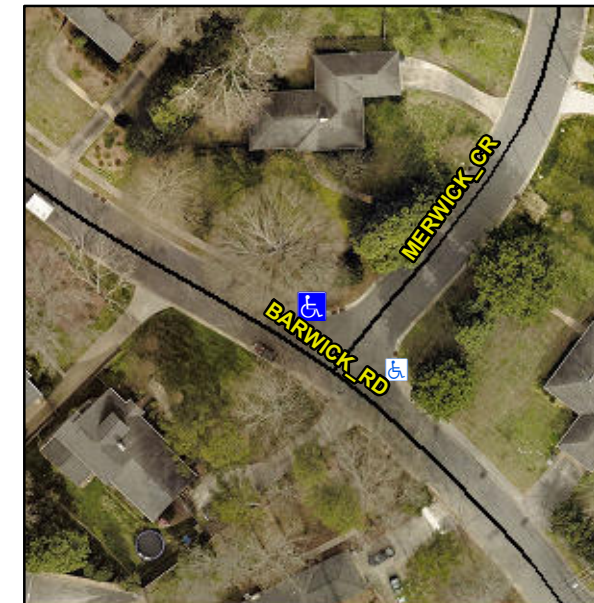
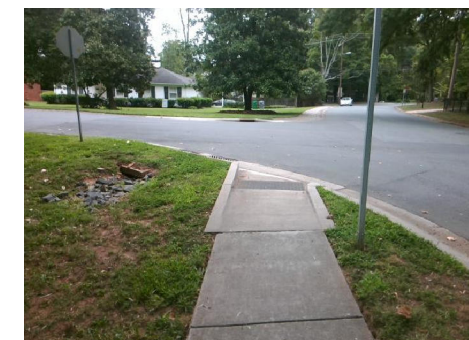
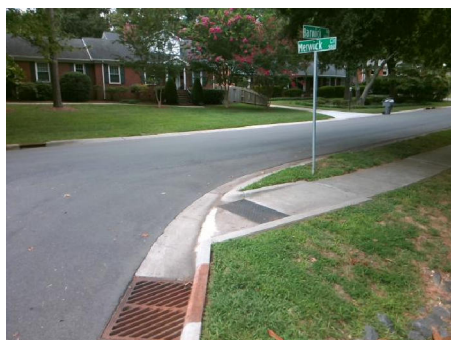
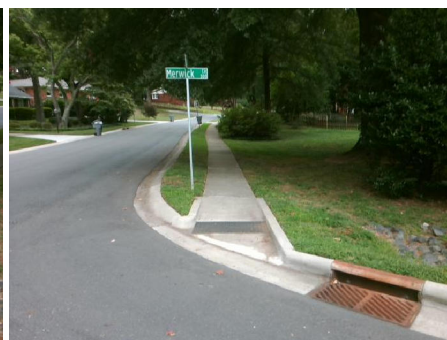
R304.5.1, R304.5.3

Compliance	Description	Data	Compliance	Description	Data
N/A	Ramp Length (in)	96.0	N/A	Grade Break?	N/A
No	Ramp Width (in)	47.0	N/A	Grade Break Slope (%)	0.0
Yes	Ramp Slope (%)	2.1	N/A	Grade Break XSlope (%)	0.0
No	Ramp XSlope (%)	6.3			
N/A	Flare Type LT	N/A	N/A	Flare Type RT	N/A
N/A	Flare Slope LT (%)	N/A	N/A	Flare Slope RT (%)	0.0
N/A	Flare Traversable LT?	N/A	N/A	Flare Traversable RT?	N/A
N/A	Landing Length (in)	0.0	N/A	DWS Provided?	N/A
N/A	Landing Width (in)	0.0	N/A	DWS Contrast?	N/A
N/A	Landing Slope (%)	0.0	N/A	DWS Length (in)	N/A
N/A	Landing X Slope (%)	0.0	N/A	DWS Full Width?	N/A
N/A	Landing Curb? (Y/N)	N/A	N/A	DWS Offset LT (in)	N/A
N/A	Shared Landing?	N/A	N/A	DWS Offset RT (in)	N/A
N/A	Gutter Ponding?	0.0	N/A	Gutter Slope (%)	N/A
N/A	Gutter Lip Ht (in)	0.0	N/A	Gutter X Slope (%)	N/A
N/A	Painted X Walk1?	No		Road Slope (%)	2.7
	X Walk 1 Direction	To SE		Road X Slope (%)	4.3
	X Walk 1 Width (in)	N/A		Clear Space?	N/A

X Walk 1 Slope (%)	2.7	N/A	Clear Space to XWalk (in)	N/A
	X Walk 1 X Slope (%)	4.3	N/A	Storm Grate/Utility Hazard?	N/A
N/A	Ramp inside XWalk1?	N/A		Storm Grate/Utility Type	
N/A	Any Obstructions?	N/A			N/A
	Obstruction Type		Yes	Surface Condition? (G/P)	Good
			N/A	Curb Slope (%)	11.6

Remove & Replace Entire Ramp.
