## Access Compliance Report Public Rights-of-Way (Curb Ramps)

Intersection ID: 11153 Main Street: E\_W\_T\_HARRIS\_BV Cross Street: N\_SHARON\_AMITY\_RD Location: NE

ADA ID: 91B9A9D20F4E Ramp Type: PerpDiag Initial Pass/Fail: Fail Overall Compliance: No Severity Score: 12.5

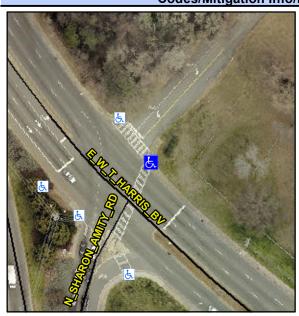
Not Found, R304.2.2

Field Measurements/Component Compilance						
Compliance Description		Data	Compli	ance	Description	Data
N/	A Ramp Length (in)	59.5	No	Ramp	Slope (%)	9.0
Ye	s Ramp Width (in)	48.0	Yes	Ramp	XSlope (%)	0.8
N/	A Flare Type LT	N/A	N/A	Flare	Type RT	N/A
N/	A Flare Slope LT (%)	N/A	N/A	Flare	Slope RT (%)	N/A
N/	A Flare Traversable LT?	N/A	N/A	Flare	Traversable RT?	N/A
N/	A Landing Length (in)	N/A	N/A	DWS	Provided?	N/A
N/	A Landing Width (in)	N/A	N/A	DWS	Contrast?	N/A
N/	A Landing Slope (%)	N/A	N/A	DWS	Length (in)	N/A
N/	A Landing X Slope (%)	N/A	N/A	DWS	Full Width?	N/A
N/	A Landing Curb? (Y/N)	N/A	N/A	DWS	Offset (in)	N/A
N/	A Shared Landing?	N/A				
N/	A Gutter Ponding?	N/A	N/A	Gutte	r Slope (%)	N/A
N/	A Gutter Lip Ht (in)	N/A	N/A	Gutte	r X Slope (%)	N/A
N/	A Painted X Walk1?	Yes	N/A	Paint	ed X Walk2?	Yes
	X Walk 1 Direction	To NW		X Wa	lk 2 Direction	To SW
N/	A X Walk 1 Width (in)	117.5	N/A	X Wa	lk 2 Width (in)	103.0

Remove & Replace Curb Ramp With Two New Directional Ramps or Equivalent.
