Access Compliance Report

Public Rights-of-Way

(Curb Ramps)

Intersection ID: 45494	Main Street: BUGGY_HORSE_RD	Cross Street: COTTON_STAND_RD	Location: NE
ADA ID: 91D3632AB87B	Ramp Type: PerpDiag	Initial Pass/Fail: Fail	Overall Compliance: No
Severity Score: 13.75			
Codes/Mitigation Info/Possible Solution		Field Measurements/Component Compliance

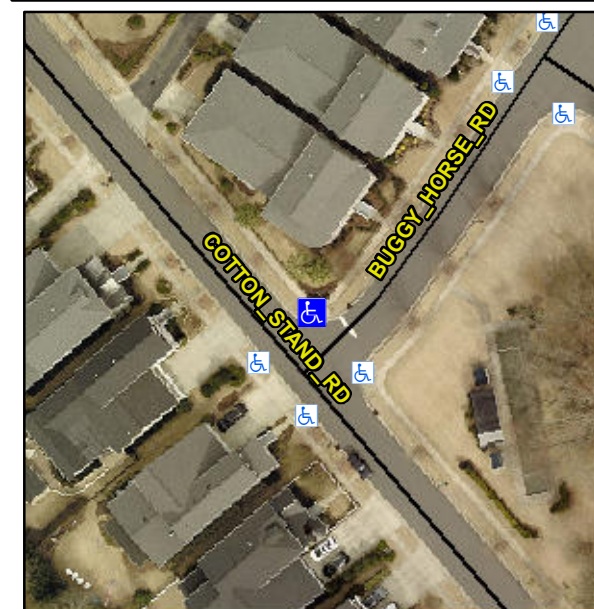
Not Found, R304.2.2, R304.5.3

Compliance	Description	Data	Compliance	Description	Data
N/A	Ramp Length (in)	77.0	No	Ramp Slope (%)	11.8
Yes	Ramp Width (in)	48.0	No	Ramp XSlope (%)	2.1
N/A	Flare Type LT	N/A	N/A	Flare Type RT	N/A
N/A	Flare Slope LT (%)	N/A	N/A	Flare Slope RT (%)	N/A
N/A	Flare Traversable LT?	N/A	N/A	Flare Traversable RT?	N/A
N/A	Landing Length (in)	N/A	N/A	DWS Provided?	N/A
N/A	Landing Width (in)	N/A	N/A	DWS Contrast?	N/A
N/A	Landing Slope (%)	N/A	N/A	DWS Length (in)	N/A
N/A	Landing X Slope (%)	N/A	N/A	DWS Full Width?	N/A
N/A	Landing Curb? (Y/N)	N/A	N/A	DWS Offset (in)	N/A
N/A	Shared Landing?	N/A			
N/A	Gutter Ponding?	N/A	N/A	Gutter Slope (%)	N/A
N/A	Gutter Lip Ht (in)	N/A	N/A	Gutter X Slope (%)	N/A
N/A	Painted X Walk1?	No	N/A	Painted X Walk2?	No
	X Walk 1 Direction	To SW		X Walk 2 Direction	To SE
N/A	X Walk 1 Width (in)	N/A	N/A	X Walk 2 Width (in)	N/A
	X Walk 1 Slope (%)	3.4		X Walk 2 Slope (%)	0.4
	X Walk 1 X Slope (%)	2.3		X Walk 2 X Slope (%)	2.7

N/A	Ramp inside XWalk1?	N/A	N/A	Ramp inside XWalk2?	N/A
	Road Slope (%)	2.1	N/A	Clear Space?	N/A
	Road X Slope (%)	2.5	N/A	Clear Space to XWalk (in)	N/A
N/A	Any Obstructions?	N/A	N/A	Storm Grate/Utility Hazard?	N/A
	Obstruction Type			Storm Grate/Utility Type	
		N/A			N/A
			Yes	Surface Condition? (G/P)	Good

Remove & Replace Curb Ramp With Two New Directional Ramps or Equivalent.
