Access Compliance Report

Public Rights-of-Way

(Curb Ramps)

Intersection ID: 43227	Main Street: N_I-77_EXIT_5_RA	Cross Street: N_I-77_HY	Location: NW
ADA ID: 91D38E70EADE	Ramp Type: Perp	Initial Pass/Fail: Fail	Overall Compliance: No
Severity Score: 21.25			
Codes/Mitigation Info/Possible Solution		Field Measurements/Component Compliance

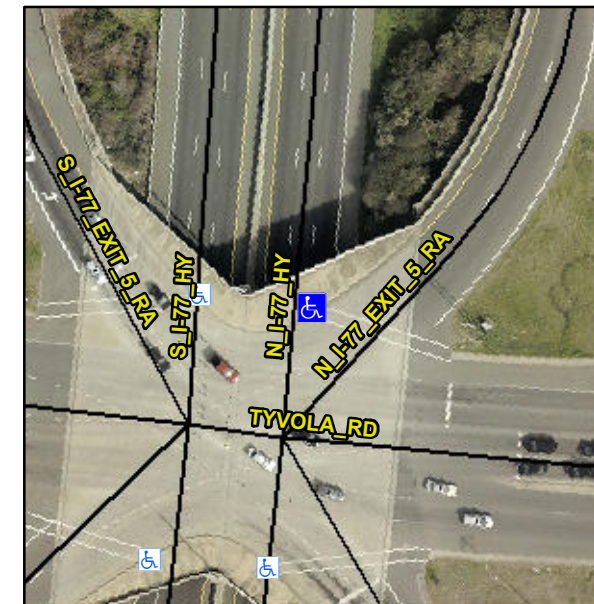
Not Found, R304.5.1, R304.2.2

Compliance	Description	Data	Compliance	Description	Data
N/A	Ramp Length (in)	86.0	No	Ramp Slope (%)	8.9
No	Ramp Width (in)	43.0	Yes	Ramp XSlope (%)	1.2
N/A	Flare Type LT	N/A	N/A	Flare Type RT	N/A
N/A	Flare Slope LT (%)	N/A	N/A	Flare Slope RT (%)	N/A
N/A	Flare Traversable LT?	N/A	N/A	Flare Traversable RT?	N/A
N/A	Landing Length (in)	N/A	N/A	DWS Provided?	N/A
N/A	Landing Width (in)	N/A	N/A	DWS Contrast?	N/A
N/A	Landing Slope (%)	N/A	N/A	DWS Length (in)	N/A
N/A	Landing X Slope (%)	N/A	N/A	DWS Full Width?	N/A
N/A	Landing Curb? (Y/N)	N/A	N/A	DWS Offset (in)	N/A
N/A	Shared Landing?	N/A			
N/A	Gutter Ponding?	N/A	N/A	Gutter Slope (%)	N/A
N/A	Gutter Lip Ht (in)	N/A	N/A	Gutter X Slope (%)	N/A
N/A	Painted X Walk1?	Yes	N/A	Painted X Walk2?	N/A
	X Walk 1 Direction	To SE		X Walk 2 Direction	N/A
N/A	X Walk 1 Width (in)	72.0	N/A	X Walk 2 Width (in)	N/A
	X Walk 1 Slope (%)	1.3		X Walk 2 Slope (%)	N/A
	X Walk 1 X Slope (%)	2.7		X Walk 2 X Slope (%)	N/A

N/A	Ramp inside XWalk1?	Yes	N/A	Ramp inside XWalk2?	N/A
	Road Slope (%)	N/A	N/A	Clear Space?	N/A
	Road X Slope (%)	N/A	N/A	Clear Space to XWalk (in)	N/A
N/A	Any Obstructions?	N/A	N/A	Storm Grate/Utility Hazard?	N/A
	Obstruction Type			Storm Grate/Utility Type	
		N/A			N/A
		Yes		Surface Condition? (G/P)	Good

Remove & Replace Entire Ramp.
