Access Compliance Report Public Rights-of-Way (Curb Ramps)

Intersection ID: 14513 Main Street: N_CHASE_ST Cross Street: VAIL_AV Location: E

ADA ID: 91D434BCC37F Ramp Type: BlendTrans2 Initial Pass/Fail: Fail Overall Compliance: No Severity Score: 1.25

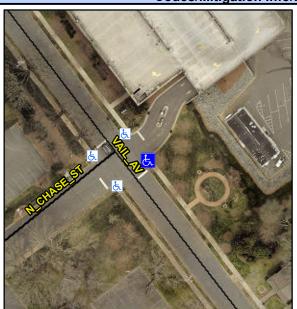
Not Found, R304.5.3

ried Measurements/Component Compliance						
	Compli	Compliance Description		Compliance Description		Data
	N/A	Ramp Length (in)	48.0	Yes	BlendTrans Slope (%)	3.4
	Yes	Ramp Width (in)	48.0	No	BlendTrans XSlope (%)	2.6
	N/A	Flare Type LT	N/A	N/A	Flare Type RT	N/A
	N/A	Flare Slope LT (%)	N/A	N/A	Flare Slope RT (%)	N/A
	N/A	Flare Traversable LT?	N/A	N/A	Flare Traversable RT?	N/A
	N/A	Landing Length (in)	N/A	N/A	DWS Provided?	N/A
	N/A	Landing Width (in)	N/A	N/A	DWS Contrast?	N/A
	N/A	Landing Slope (%)	N/A	N/A	DWS Length (in)	N/A
	N/A	Landing X Slope (%)	N/A	N/A	DWS Full Width?	N/A
	N/A	Landing Curb? (Y/N)	N/A	N/A	DWS Offset (in)	N/A
	N/A	Shared Landing?	N/A			
	N/A	Gutter Ponding?	N/A	N/A	Gutter Slope (%)	N/A
	N/A	Gutter Lip Ht (in)	N/A	N/A	Gutter X Slope (%)	N/A
	N/A	Painted X Walk1?	No	N/A	Painted X Walk2?	No
		X Walk 1 Direction	To NW		X Walk 2 Direction	To SW
		X Walk 1 Width (in)	N/A		X Walk 2 Width (in)	N/A

X Walk 1 Slope (%)	1.8		X Walk 2 Slope (%)	5.8
		X Walk 1 X Slope (%)	1.5		X Walk 2 X Slope (%)	3.1
	N/A	Ramp inside XWalk1?	N/A	N/A	Ramp inside XWalk2?	N/A
		Road Slope (%)	3.2		Clear Space?	N/A
		Road X Slope (%)	0.5	N/A	Clear Space to XWalk (in)	N/A
	N/A	Any Obstructions?	N/A	N/A	Storm Grate/Utility Hazard?	N/A

Remove & Replace Curb Ramp With Two New Directional Ramps or Equivalent.
