Access Compliance Report

Public Rights-of-Way

(Curb Ramps)

Intersection ID: 42790	Main Street: CALDWELL_CROSSING_PY	Cross Street: ERWIN_RIDGE_AV	Location: NW
ADA ID: 91D70775FE8B	Ramp Type: PerpDiag	Initial Pass/Fail: Fail	Overall Compliance: No
		Severity Score: 8.75

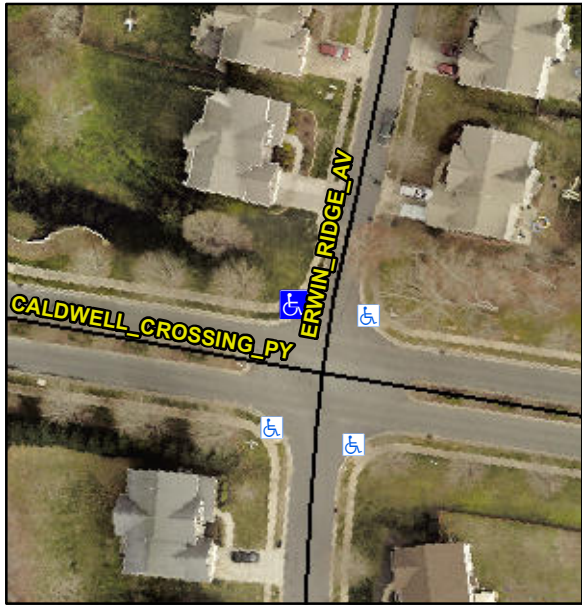
Possible Solutions:		Compliance	Description	Data	Compliance	Description	Data
	Remove & Replace Curb Ramp With Two New Directional Ramps or Equivalent.		N/A	Ramp Length (in)	48.0	Yes	Ramp Slope (%)	6.2
			No	Ramp Width (in)	44.0	Yes	Ramp XSlope (%)	0.8
			N/A	Flare Type LT	N/A	N/A	Flare Type RT	N/A
			N/A	Flare Slope LT (%)	N/A	N/A	Flare Slope RT (%)	N/A
			N/A	Flare Traversable LT?	N/A	N/A	Flare Traversable RT?	N/A
			N/A	Landing Length (in)	N/A	N/A	DWS Provided?	N/A
			N/A	Landing Width (in)	N/A	N/A	DWS Contrast?	N/A
			N/A	Landing Slope (%)	N/A	N/A	DWS Length (in)	N/A
			N/A	Landing X Slope (%)	N/A	N/A	DWS Full Width?	N/A
Surveyor Notes:	N/A		N/A	Landing Curb? (Y/N)	N/A	N/A	DWS Offset (in)	N/A
			N/A	Shared Landing?	N/A			
	PROW/ADA:		N/A	Gutter Ponding?	N/A	N/A	Gutter Slope (%)	N/A
	Not Found, R304.5.1		N/A	Gutter Lip Ht (in)	N/A	N/A	Gutter X Slope (%)	N/A

N/A	Painted X Walk1?	No	N/A	Painted X Walk2?	No
				X Walk 1 Direction	To SW		X Walk 2 Direction	To E
			N/A	X Walk 1 Width (in)	N/A	N/A	X Walk 2 Width (in)	N/A
				X Walk 1 Slope (%)	8.1		X Walk 2 Slope (%)	4.5
				X Walk 1 X Slope (%)	1.7		X Walk 2 X Slope (%)	5.1
			N/A	Ramp inside XWalk1?	N/A	N/A	Ramp inside XWalk2?	N/A
			Road Slope (%)	2.2	N/A	Clear Space?	N/A	
			Road X Slope (%)	8.3	N/A	Clear Space to XWalk (in)	N/A	
		N/A	Any Obstructions?	N/A	N/A	Storm Grate/Utility Hazard?	N/A	
			Obstruction Type			Storm Grate/Utility Type		
				N/A			N/A	
					Yes	Surface Condition? (G/P)	Good	
Total Cost:		\$	3200.00
