Access Compliance Report

Public Rights-of-Way

(Curb Ramps)

| Intersection ID: 54151 | Main Street: SANDERS_FARM_LN | Cross Street: WALNUT_FOREST_DR | Location: SW |

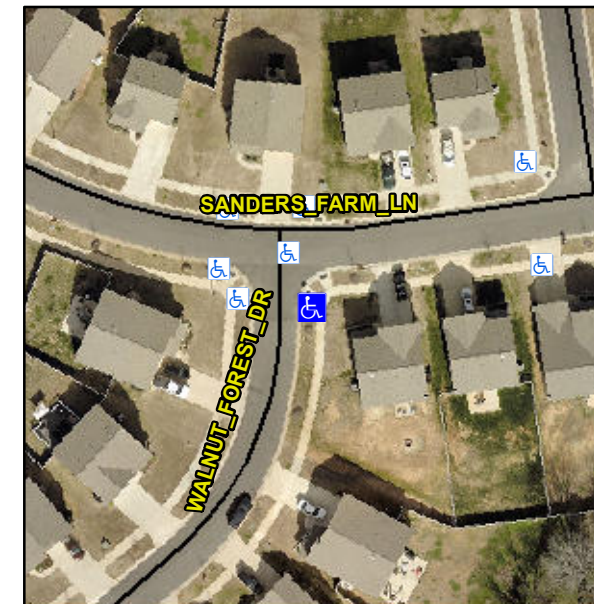
| ADA ID: 91EF6A6113B0 | Ramp Type: Perp | Initial Pass/Fail: Fail | Overall Compliance: No |
| Severity Score: 22.5 | | | |

Not Found, R304.5.1, R304.2.2, R304.5.3

| Compliance | Description | Data | Compliance | Description | Data |
|---|---|---|---|---|---|
| N/A | Ramp Length (in) | 96.0 | No | Ramp Slope (%) | 8.5 |
| No | Ramp Width (in) | 46.0 | No | Ramp XSlope (%) | 2.4 |

Remove & Replace Entire Ramp.

Total Cost: \$ 1850.00

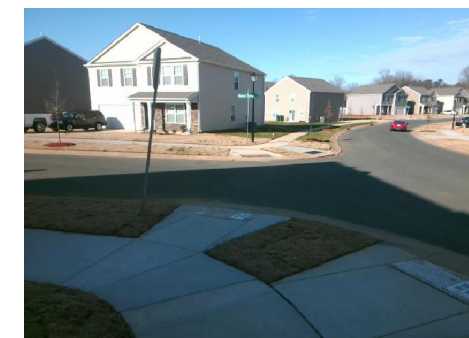
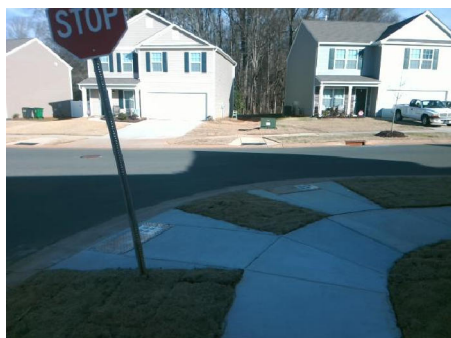
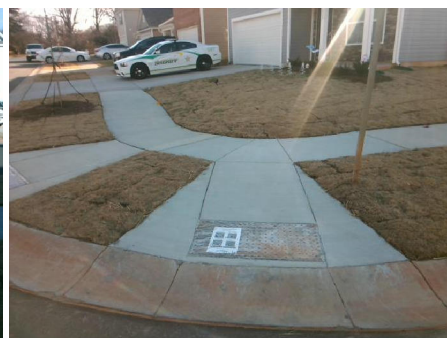
| Compliance | Description | Data | Compliance | Description | Data |
|---|---|---|---|---|---|
| N/A | Gutter Lip Ht (in) | 1.3 | N/A | Gutter X Slope (%) | N/A |
