Access Compliance Report

Public Rights-of-Way

(Curb Ramps)

Intersection ID: 10027126	Main Street: GARDEN_TR	Cross Street: N/A	Location: N
ADA ID: 91F30D35189F	Ramp Type: PerpDiag	Initial Pass/Fail: Fail	Overall Compliance: No
Severity Score: 22.5			
Codes/Mitigation Info/Possible Solution		Field Measurements/Component Compliance

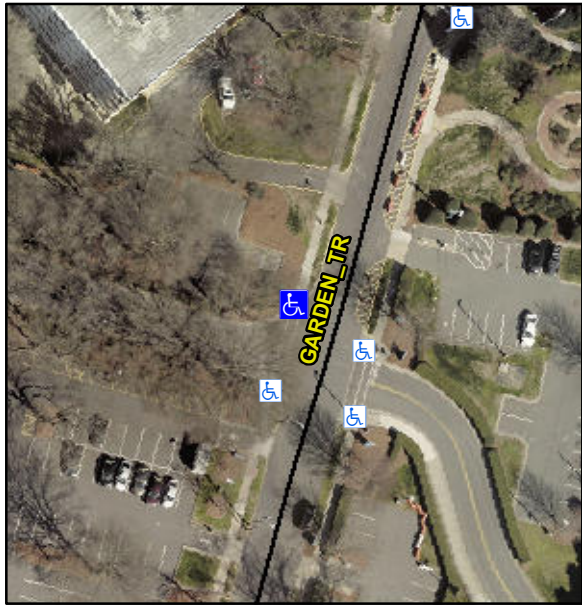
Possible Solutions:		Compliance		Description		Data		Compliance		Description		Data	
	Remove & Replace Curb Ramp With Two New Directional Ramps or Equivalent.		N/A	Ramp Length (in)	29.5	No	Ramp Slope (%)	10.7						
			No	Ramp Width (in)	43.0	No	Ramp XSlope (%)	4.9						
			N/A	Flare Type LT	N/A	N/A	Flare Type RT	N/A						
			N/A	Flare Slope LT (%)	N/A	N/A	Flare Slope RT (%)	N/A						
			N/A	Flare Traversable LT?	N/A	N/A	Flare Traversable RT?	N/A						
			N/A	Landing Length (in)	N/A	N/A	DWS Provided?	N/A						
			N/A	Landing Width (in)	N/A	N/A	DWS Contrast?	N/A						
			N/A	Landing Slope (%)	N/A	N/A	DWS Length (in)	N/A						
			N/A	Landing X Slope (%)	N/A	N/A	DWS Full Width?	N/A						
<p>Surveyor Notes:</p> <p>N/A</p> <p>PROW/ADA:</p> <p>Not Found, R304.5.1, R304.2.2, R304.5.3</p>			N/A	Landing Curb? (Y/N)	N/A	N/A	DWS Offset (in)	N/A						
			N/A	Shared Landing?	N/A									
			N/A	Gutter Ponding?	N/A	N/A	Gutter Slope (%)	N/A

N/A	Gutter Lip Ht (in)	N/A	N/A	Gutter X Slope (%)	N/A						
			N/A	Painted X Walk1?	Yes	N/A	Painted X Walk2?	No						
				X Walk 1 Direction	To SE		X Walk 2 Direction	To SW						
			N/A	X Walk 1 Width (in)	55.0	N/A	X Walk 2 Width (in)	N/A						
				X Walk 1 Slope (%)	2.9		X Walk 2 Slope (%)	1.4						
				X Walk 1 X Slope (%)	0.5		X Walk 2 X Slope (%)	1.6						
			N/A	Ramp inside XWalk1?	Yes	N/A	Ramp inside XWalk2?	N/A						
<p>Street 1 Name</p> <p>ENTRANCE</p> <p>Stop Condition-Street 2</p> <p>StopSign</p> <p>Street 2 Name</p> <p>GARDEN TR</p> <p>Stop Condition-Street 1</p> <p>None</p>				Road Slope (%)	3.0	N/A	Clear Space?	N/A						
				Road X Slope (%)	1.9	N/A	Clear Space to XWalk (in)	N/A						
			N/A	Any Obstructions?	N/A	N/A	Storm Grate/Utility Hazard?	N/A						
				Obstruction Type			Storm Grate/Utility Type							
						N/A		N/A						
						Yes	Surface Condition? (G/P)	Good						
Total Cost:		\$	3200.00
