Access Compliance Report

Public Rights-of-Way

(Curb Ramps)

Intersection ID: 28045	Main Street: PROVIDENCE_COUNTRY_CLUB_DR	Cross Street: ROYAL_PORTRUSH_DR	Location: S
ADA ID: 920DD3D6C1D4	Ramp Type: BlendTrans1	Initial Pass/Fail: Fail	Overall Compliance: No
Codes/Mitigation Info/Possible Solution		Field Measurements/Component Compliance	
Severity Score: 1.25

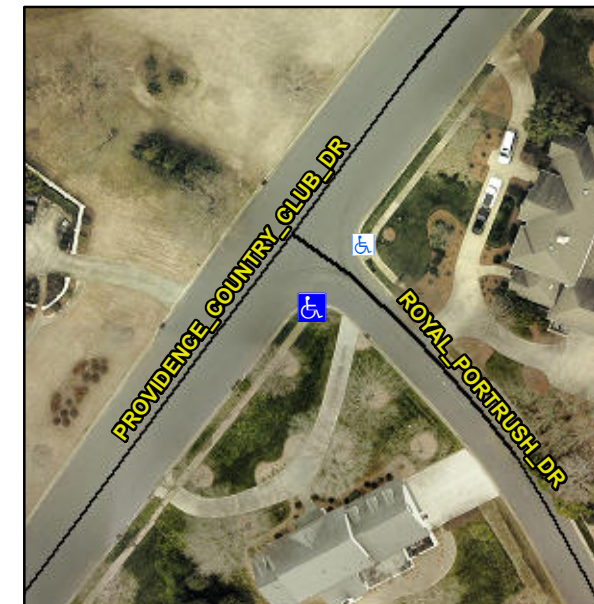
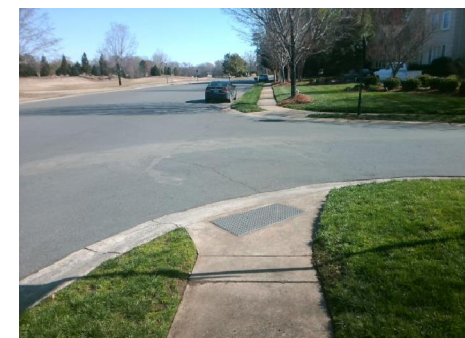
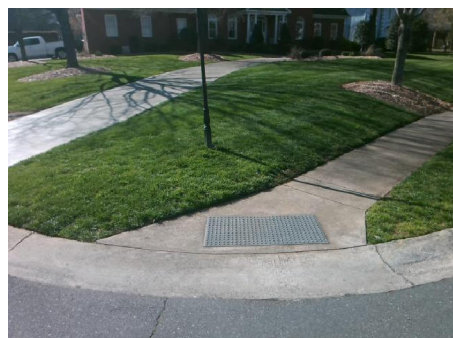
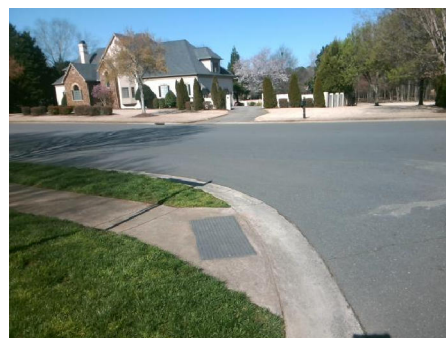
Not Found, R304.5.3

Compliance	Description	Data	Compliance	Description	Data
N/A	Ramp Length (in)	55.0	Yes	BlendTrans Slope (%)	4.0
Yes	Ramp Width (in)	48.0	No	BlendTrans XSlope (%)	3.6
N/A	Flare Type LT	N/A	N/A	Flare Type RT	N/A
N/A	Flare Slope LT (%)	N/A	N/A	Flare Slope RT (%)	N/A
N/A	Flare Traversable LT?	N/A	N/A	Flare Traversable RT?	N/A
N/A	Landing Length (in)	N/A	N/A	DWS Provided?	N/A
N/A	Landing Width (in)	N/A	N/A	DWS Contrast?	N/A
N/A	Landing Slope (%)	N/A	N/A	DWS Length (in)	N/A
N/A	Landing X Slope (%)	N/A	N/A	DWS Full Width?	N/A
N/A	Landing Curb? (Y/N)	N/A	N/A	DWS Offset (in)	N/A
N/A	Shared Landing?	N/A			
N/A	Gutter Ponding?	N/A	N/A	Gutter Slope (%)	N/A
N/A	Gutter Lip Ht (in)	N/A	N/A	Gutter X Slope (%)	N/A
N/A	Painted X Walk1?	No	N/A	Painted X Walk2?	N/A
	X Walk 1 Direction	To NE		X Walk 2 Direction	N/A
	X Walk 1 Width (in)	N/A		X Walk 2 Width (in)	N/A
	X Walk 1 Slope (%)	2.2		X Walk 2 Slope (%)	N/A
	X Walk 1 X Slope (%)	4.1		X Walk 2 X Slope (%)	N/A

N/A	Ramp inside XWalk1?	N/A	N/A	Ramp inside XWalk2?	N/A
	Road Slope (%)	4.1		Clear Space?	N/A
	Road X Slope (%)	2.2	N/A	Clear Space to XWalk (in)	N/A
N/A	Any Obstructions?	N/A	N/A	Storm Grate/Utility Hazard?	N/A
	Obstruction Type			Storm Grate/Utility Type	
		N/A			N/A
			Yes	Surface Condition? (G/P)	Good
			No	Curb Slope (%)	17.0

Remove & Replace Curb Ramp With Two New Directional Ramps or Equivalent.
