Access Compliance Report

Public Rights-of-Way

(Curb Ramps)

| Intersection ID: 8206 | Main Street: BURBANK_DR | Cross Street: SOUTHWEST_BV | Location: NE |

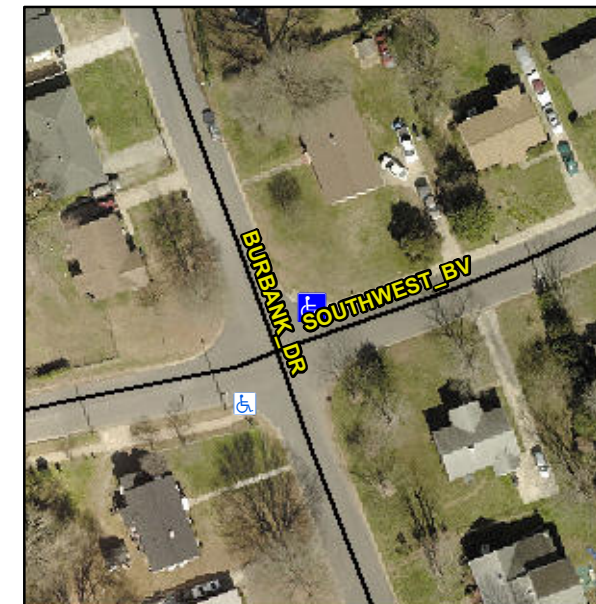
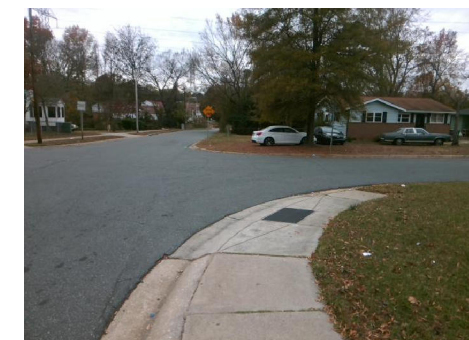
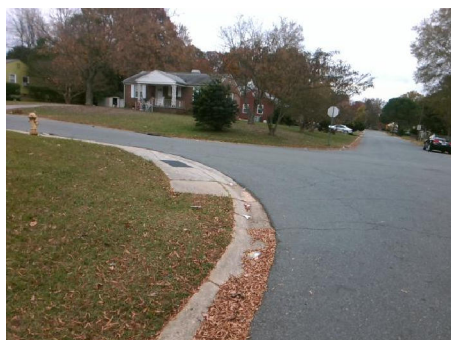
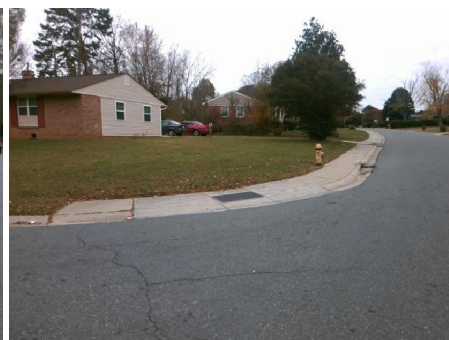
| ADA ID: 9211790CDE87 | Ramp Type: Perp | Initial Pass/Fail: Fail | Overall Compliance: No |
| Severity Score: 21.25 | | | |

Not Found, R304.5.1, R304.5.3

| Compliance | Description | Data | Compliance | Description | Data |
|---|---|---|---|---|---|
| N/A | Ramp Length (in) | 48.0 | Yes | Ramp Slope (%) | 5.0 |
| No | Ramp Width (in) | 43.0 | No | Ramp XSlope (%) | 5.7 |

Remove & Replace Entire Ramp.

Total Cost: \$ 1850.00
