Access Compliance Report

Public Rights-of-Way

(Curb Ramps)

| Intersection ID: 10023017 | Main Street: CENTER_PARK_DR | Cross Street: N/A | Location: NW |

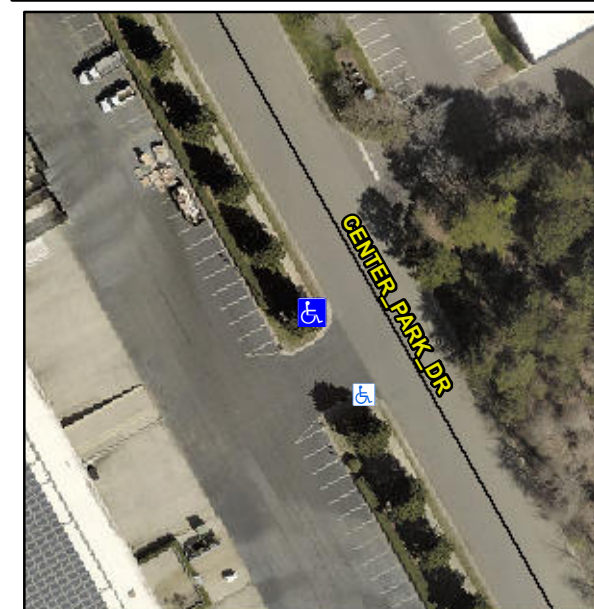
| ADA ID: 921A5BBEECE3 | Ramp Type: PerpDiag | Initial Pass/Fail: Fail | Overall Compliance: No |
| Severity Score: 21.25 | | | |

Not Found, R304.5.1, R304.5.3

| Compliance | Description | Data | Compliance | Description | Data |
|---|---|---|---|---|---|
| N/A | Ramp Length (in) | 74.0 | Yes | Ramp Slope (%) | 5.2 |
| No | Ramp Width (in) | 46.0 | No | Ramp XSlope (%) | 6.3 |

Remove & Replace Curb Ramp With Two New Directional Ramps or Equivalent.

Total Cost: \$ 3200.00
