Access Compliance Report

(Curb Ramps)

Intersection ID: 20213	Main Street: COLLINGHAM_DR	Cross Street: QUEENSMEAD_CR	Location: SW
ADA ID: 92260DB85238	Ramp Type: Directional1	Initial Pass/Fail: Fail	Overall Compliance: No
		Severity Score: 8.75

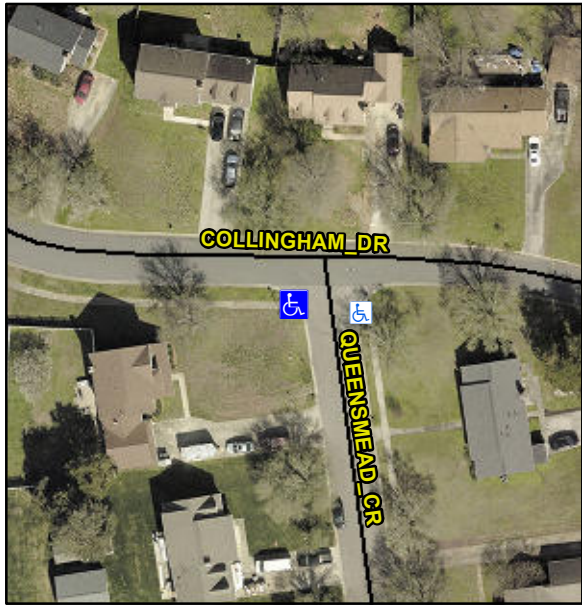
Possible Solutions:		Compliance			Description			Data	
	Remove & Replace Entire Ramp.		N/A	Ramp Length (in)	65.0	N/A	Grade Break?	N/A		
			No	Ramp Width (in)	45.5	N/A	Grade Break Slope (%)	0.0		
			Yes	Ramp Slope (%)	0.7	N/A	Grade Break XSlope (%)	0.0		
			Yes	Ramp XSlope (%)	0.2					
			N/A	Flare Type LT	N/A	N/A	Flare Type RT	N/A		
			N/A	Flare Slope LT (%)	N/A	N/A	Flare Slope RT (%)	0.0		
			N/A	Flare Traversable LT?	N/A	N/A	Flare Traversable RT?	N/A		
			N/A	Landing Length (in)	0.0	N/A	DWS Provided?	N/A		
			N/A	Landing Width (in)	0.0	N/A	DWS Contrast?	N/A		
		N/A	Landing Slope (%)	0.0	N/A	DWS Length (in)	N/A			
		N/A	Landing X Slope (%)	0.0	N/A	DWS Full Width?	N/A			
		N/A	Landing Curb? (Y/N)	N/A	N/A	DWS Offset LT (in)	N/A			
		N/A	Shared Landing?	N/A	N/A	DWS Offset RT (in)	N/A			
		N/A	Gutter Ponding?	0.0	N/A	Gutter Slope (%)	N/A

N/A	Gutter Lip Ht (in)	0.0	N/A	Gutter X Slope (%)	N/A			
		N/A	Painted X Walk1?	No		Road Slope (%)	4.4			
			X Walk 1 Direction	To NE		Road X Slope (%)	2.5			
			X Walk 1 Width (in)	N/A		Clear Space?	N/A			
			X Walk 1 Slope (%)	4.4	N/A	Clear Space to XWalk (in)	N/A			
			X Walk 1 X Slope (%)	2.5	N/A	Storm Grate/Utility Hazard?	N/A			
		N/A	Ramp inside XWalk1?	N/A		Storm Grate/Utility Type				
		N/A	Any Obstructions?	N/A			N/A			
			Obstruction Type		Yes	Surface Condition? (G/P)	Good			
					N/A	Curb Slope (%)	2.5			
Surveyor Notes:										
N/A										
PROW/ADA:										
R304.5.1										
Total Cost:		\$	1600.00							
Street 1 Name		QUEENSMEAD CR								
Stop Condition-Street 1		StopSign								
Street 2 Name		N/A								
Stop Condition-Street 2		N/A
