Access Compliance Report Public Rights-of-Way (Curb Ramps)

Intersection ID: 10559 Main Street: CHARLES AV Cross Street: E 35TH ST Location: W Initial Pass/Fail: Fail **Overall Compliance: No Severity Score:** ADA ID: 9226E6F38391 Ramp Type: PerpDiag 22.5

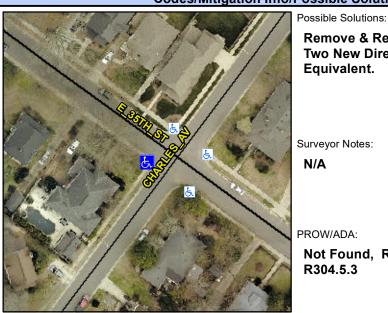
Surveyor Notes: N/A PROW/ADA: Not Found, R304.5.1, R304.2.2, R304.5.3

Total Cost: 3200.00

Possible Solution		Field Me
Possible Solutions:	Comp	liance Description
Remove & Replace Curb Ramp With Two New Directional Ramps or Equivalent.	N/A	Ramp Length (in)
	No	Ramp Width (in)
	N/A	Flare Type LT
	N/A	Flare Slope LT (%)
	N/A	Flare Traversable LT
	N/A	Landing Length (in)
Surveyor Notes:	N/A	Landing Width (in)
N/A	N/A	Landing Slope (%)
	N/A	Landing X Slope (%
	N/A	Landing Curb? (Y/N
	N/A	Shared Landing?
PROW/ADA:	N/A	Gutter Ponding?
Not Found, R304.5.1, R304.2.2,	N/A	Gutter Lip Ht (in)
R304.5.3	N/A	Painted X Walk1?
		X Walk 1 Direction
	N/A	X Walk 1 Width (in)
		X Walk 1 Slope (%)
		X Walk 1 X Slope (%
