Access Compliance Report

Public Rights-of-Way

(Curb Ramps)

Intersection ID: 30455	Main Street: HARMONY_GLEN_CT	Cross Street: WALLAND_LN	Location: NW
ADA ID: 9237B18E1A85	Ramp Type: BlendTrans2	Initial Pass/Fail: Fail	Overall Compliance: No
Severity Score: 8.75			
Codes/Mitigation Info/Possible Solution		Field Measurements/Component Compliance

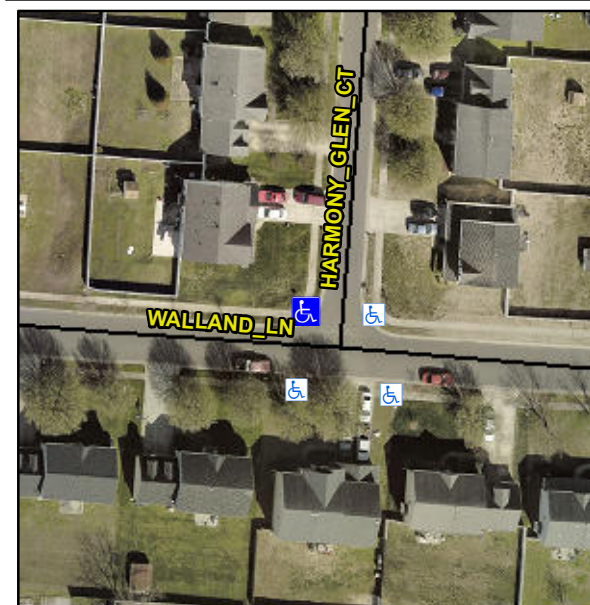
R304.5.1

Compliance	Description	Data	Compliance	Description	Data
N/A	Ramp Length (in)	95.0	Yes	BlendTrans Slope (%)	3.1
No	Ramp Width (in)	46.0	Yes	BlendTrans XSlope (%)	0.1
N/A	Flare Type LT	N/A	N/A	Flare Type RT	N/A
N/A	Flare Slope LT (%)	N/A	N/A	Flare Slope RT (%)	N/A
N/A	Flare Traversable LT?	N/A	N/A	Flare Traversable RT?	N/A
N/A	Landing Length (in)	N/A	N/A	DWS Provided?	N/A
N/A	Landing Width (in)	N/A	N/A	DWS Contrast?	N/A
N/A	Landing Slope (%)	N/A	N/A	DWS Length (in)	N/A
N/A	Landing X Slope (%)	N/A	N/A	DWS Full Width?	N/A
N/A	Landing Curb? (Y/N)	N/A	N/A	DWS Offset (in)	N/A
N/A	Shared Landing?	N/A			
N/A	Gutter Ponding?	N/A	N/A	Gutter Slope (%)	N/A
N/A	Gutter Lip Ht (in)	N/A	N/A	Gutter X Slope (%)	N/A
N/A	Painted X Walk1?	No	N/A	Painted X Walk2?	No
	X Walk 1 Direction	To S		X Walk 2 Direction	To E
	X Walk 1 Width (in)	N/A		X Walk 2 Width (in)	N/A
	X Walk 1 Slope (%)	0.7		X Walk 2 Slope (%)	1.1
	X Walk 1 X Slope (%)	0.8		X Walk 2 X Slope (%)	2.6

N/A	Ramp inside XWalk1?	N/A	N/A	Ramp inside XWalk2?	N/A
	Road Slope (%)	0.0		Clear Space?	N/A
	Road X Slope (%)	1.2	N/A	Clear Space to XWalk (in)	N/A
N/A	Any Obstructions?	N/A	N/A	Storm Grate/Utility Hazard?	N/A
	Obstruction Type			Storm Grate/Utility Type	
		N/A			N/A
			Yes	Surface Condition? (G/P)	Good
			N/A	Curb Slope (%)	0.9

Remove & Replace Curb Ramp With Two New Directional Ramps or Equivalent.
