Access Compliance Report Public Rights-of-Way (Curb Ramps)

· · · ·										
Intersection ID: 50463	Main Str	Main Street: EVERTON_DR			reet:	LENOX_POINTE_DR	Location:	SE		
ADA ID: 925BE28234A7	Ramp Ty	Ramp Type: Perp			ss/Fa	nil: Pass Overall	o Severity Score:	5.25		
Codes/Mitigation Info/Possible Solution				Field Measurements/Component Compliance						
A CONTRACTOR	1 Mail	Possible Solutions:		Compliance Description			Data Compliance Description			Data
	11201- 5	Remove & Replace En	e Entire Ramp.		N/A	Ramp Length (in)	68.0	Yes	Ramp Slope (%)	6.1
		Remove & Replac			Yes	Ramp Width (in)	48.0	No	Ramp XSlope (%)	2.3
	211- 100			I	N/A	Flare Type LT	Sloped	N/A	Flare Type RT	N/A
	7 4 30 4 11				N/A	Flare Slope LT (%)	3.4	N/A	Flare Slope RT (%)	7.7
	<u>6.</u>			I	N/A	Flare Traversable LT?	No	N/A	Flare Traversable RT?	No
A A A A A A A A A A A A A A A A A A A	Titra				Yes	Landing Length (in)	90.0	Yes	DWS Provided?	Yes
	DR	Surveyor Notes:			Yes	Landing Width (in)	51.0	Yes	DWS Contrast?	Yes

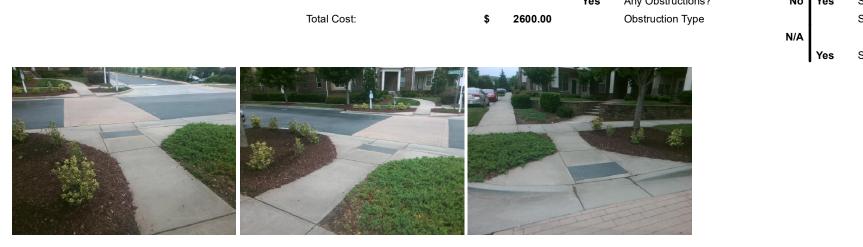
N/A			No	Landing Slope (%)	2.5	Yes	DWS Length (in)	24.0
				•	Yes	Landing X Slope (%)	1.2	Yes	DWS Full Width?	Yes
					N/A	Landing Curb? (Y/N)	No	No	DWS Offset (in)	4.5
a factor					N/A	Shared Landing?	No

1.00 11	PROW/ADA:		Yes	Gutter Ponding?	No	No	Gutter Slope (%)	5.2	
- m Klipt	Land F	Not Found, R304.	5.3, R304.2.2-Pe	erp,	Yes	Gutter Lip Ht (in)	0.0	Yes	Gutter X Slope (%)	1.7
