Access Compliance Report

Public Rights-of-Way

(Curb Ramps)

Intersection ID: 10589	Main Street: N_GRAHAM_ST	Cross Street: ARMOUR_DR	Location:	W
ADA ID: 926857F59A8B	Ramp Type: PerpDiag	Initial Pass/Fail: Fail	Overall Compliance: No	Severity Score: 25

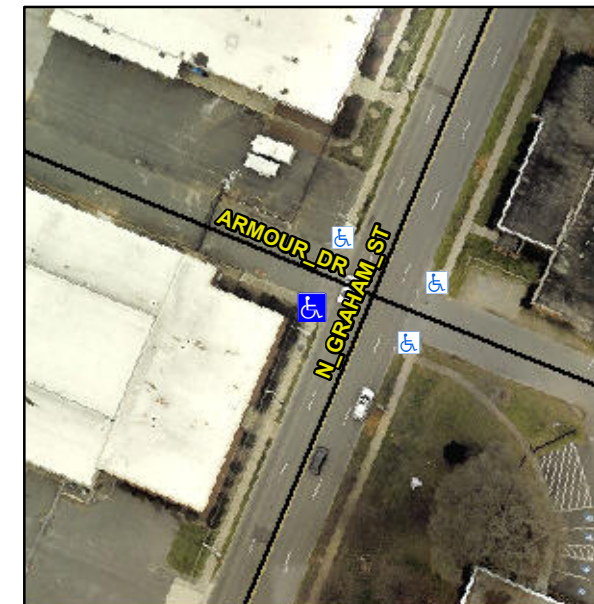
Compliance	Description	Data	Compliance	Description	Data
N/A	Ramp Length (in)	38.0	No	Ramp Slope (%)	16.1
Yes	Ramp Width (in)	48.0	Yes	Ramp XSlope (%)	1.5
N/A	Flare Type LT	N/A	N/A	Flare Type RT	N/A
N/A	Flare Slope LT (%)	N/A	N/A	Flare Slope RT (%)	N/A
N/A	Flare Traversable LT?	N/A	N/A	Flare Traversable RT?	N/A
N/A	Landing Length (in)	N/A	N/A	DWS Provided?	N/A
N/A	Landing Width (in)	N/A	N/A	DWS Contrast?	N/A
N/A	Landing Slope (%)	N/A	N/A	DWS Length (in)	N/A
N/A	Landing X Slope (%)	N/A	N/A	DWS Full Width?	N/A
N/A	Landing Curb? (Y/N)	N/A	N/A	DWS Offset (in)	N/A
N/A	Shared Landing?	N/A			
N/A	Gutter Ponding?	N/A	N/A	Gutter Slope (%)	N/A
N/A	Gutter Lip Ht (in)	N/A	N/A	Gutter X Slope (%)	N/A
N/A	Painted X Walk1?	No	N/A	Painted X Walk2?	No
	X Walk 1 Direction	To SE		X Walk 2 Direction	To NE
N/A	X Walk 1 Width (in)	N/A	N/A	X Walk 2 Width (in)	N/A
	X Walk 1 Slope (%)	3.3		X Walk 2 Slope (%)	1.2
	X Walk 1 X Slope (%)	1.5		X Walk 2 X Slope (%)	4.3

N/A	Ramp inside XWalk1?	N/A	N/A	Ramp inside XWalk2?	N/A
	Road Slope (%)	5.4	N/A	Clear Space?	N/A
	Road X Slope (%)	3.9	N/A	Clear Space to XWalk (in)	N/A
N/A	Any Obstructions?	N/A	N/A	Storm Grate/Utility Hazard?	N/A
	Obstruction Type			Storm Grate/Utility Type	
		N/A			N/A
			Yes	Surface Condition? (G/P)	Good

Possible Solutions:

Remove & Replace Curb Ramp With Two New Directional Ramps or Equivalent.

Total Cost: \$ 3200.00
