# Access Compliance Report

## Public Rights-of-Way

### (Curb Ramps)

| Intersection ID: 43869 | Main Street: CALDWELL_RIDGE_PY | Cross Street: SIDNEY_CREST_AV | Location: SE |

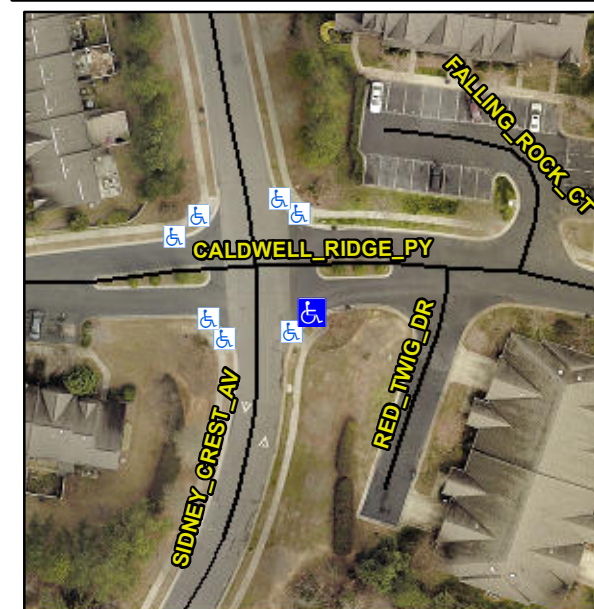
| ADA ID: 926B01D94A84 | Ramp Type: BlendTrans1 | Initial Pass/Fail: Fail | Overall Compliance: No |
| Severity Score: 8.75 | | | |

**Not Found, R304.5.1**

| Compliance | Description | Data | Compliance | Description | Data |
|---|---|---|---|---|---|
| No | Ramp Width (in) | 43.0 | Yes | BlendTrans XSlope (%) | 0.7 |
| | | | No | Curb Slope (%) | 26.9 |

**Remove & Replace Curb Ramp With Two New Directional Ramps or Equivalent.**

Total Cost: \$ 3200.00
