# Access Compliance Report

## Public Rights-of-Way

### (Curb Ramps)

Intersection ID: 47911	Main Street: ROOK_RD	Cross Street: RINGNECK_RD	Location: SE
ADA ID: 926E5CD3B385	Ramp Type: PerpDiag	Initial Pass/Fail: Fail	Overall Compliance: No
Severity Score: 12.5			
Codes/Mitigation Info/Possible Solution		Field Measurements/Component Compliance

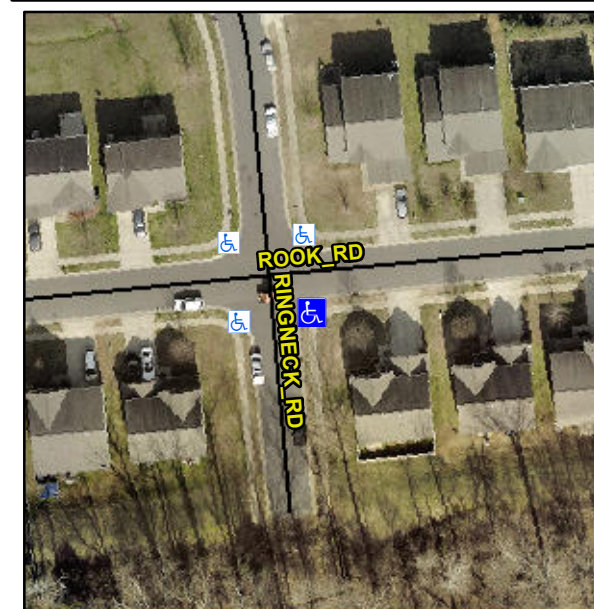
Compliance	Description	Data	Compliance	Description	Data
N/A	Ramp Length (in)	48.5	No	Ramp Slope (%)	8.9
Yes	Ramp Width (in)	48.0	Yes	Ramp XSlope (%)	1.6
N/A	Flare Type LT	N/A	N/A	Flare Type RT	N/A
N/A	Flare Slope LT (%)	N/A	N/A	Flare Slope RT (%)	N/A
N/A	Flare Traversable LT?	N/A	N/A	Flare Traversable RT?	N/A
N/A	Landing Length (in)	N/A	N/A	DWS Provided?	N/A
N/A	Landing Width (in)	N/A	N/A	DWS Contrast?	N/A
N/A	Landing Slope (%)	N/A	N/A	DWS Length (in)	N/A
N/A	Landing X Slope (%)	N/A	N/A	DWS Full Width?	N/A
N/A	Landing Curb? (Y/N)	N/A	N/A	DWS Offset (in)	N/A
N/A	Shared Landing?	N/A			
N/A	Gutter Ponding?	N/A	N/A	Gutter Slope (%)	N/A
N/A	Gutter Lip Ht (in)	N/A	N/A	Gutter X Slope (%)	N/A
N/A	Painted X Walk1?	No	N/A	Painted X Walk2?	No
	X Walk 1 Direction	To N		X Walk 2 Direction	To W
N/A	X Walk 1 Width (in)	N/A	N/A	X Walk 2 Width (in)	N/A
	X Walk 1 Slope (%)	2.2		X Walk 2 Slope (%)	2.8
	X Walk 1 X Slope (%)	0.6		X Walk 2 X Slope (%)	3.5

N/A	Ramp inside XWalk1?	N/A	N/A	Ramp inside XWalk2?	N/A
	Road Slope (%)	2.3	N/A	Clear Space?	N/A
	Road X Slope (%)	2.4	N/A	Clear Space to XWalk (in)	N/A
N/A	Any Obstructions?	N/A	N/A	Storm Grate/Utility Hazard?	N/A
	Obstruction Type			Storm Grate/Utility Type	
		N/A			N/A
		Yes		Surface Condition? (G/P)	Good

Possible Solutions:

**Remove & Replace Curb Ramp With Two New Directional Ramps or Equivalent.**

Total Cost: \$ 3200.00

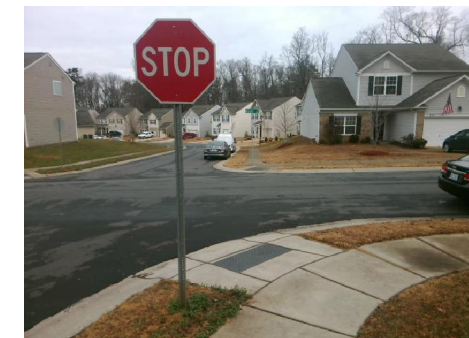
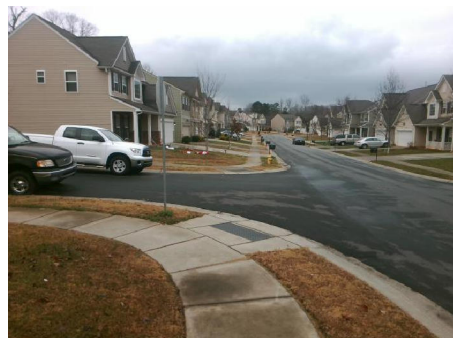
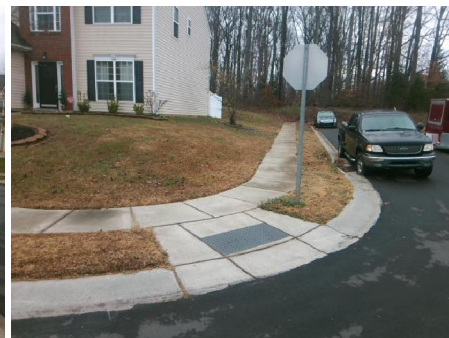
Street 1 Name ROOK RD  
 Stop Condition-Street 2 None  
 Street 2 Name RINGNECK RD  
 Stop Condition-Street 1 StopSign
