Access Compliance Report

Public Rights-of-Way

(Curb Ramps)

Intersection ID: 50475	Main Street: BRONWIN_ST	Cross Street: S_TRYON_ST	Location: NW
ADA ID: 927D6F7C00F6	Ramp Type: Perp	Initial Pass/Fail: Fail	Overall Compliance: No
		Severity Score: 8.75

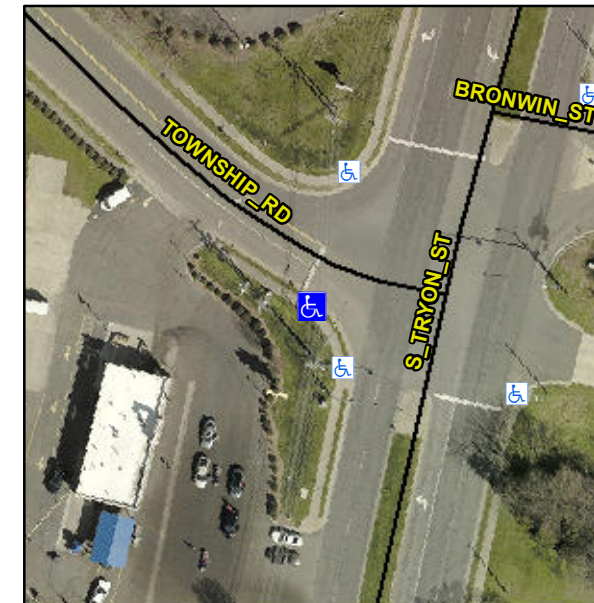
Not Found, R304.5.1

Compliance	Description	Data	Compliance	Description	Data
N/A	Ramp Length (in)	31.0	Yes	Ramp Slope (%)	7.6
No	Ramp Width (in)	45.0	Yes	Ramp XSlope (%)	1.9
N/A	Flare Type LT	N/A	N/A	Flare Type RT	N/A
N/A	Flare Slope LT (%)	N/A	N/A	Flare Slope RT (%)	N/A
N/A	Flare Traversable LT?	N/A	N/A	Flare Traversable RT?	N/A
N/A	Landing Length (in)	N/A	N/A	DWS Provided?	N/A
N/A	Landing Width (in)	N/A	N/A	DWS Contrast?	N/A
N/A	Landing Slope (%)	N/A	N/A	DWS Length (in)	N/A
N/A	Landing X Slope (%)	N/A	N/A	DWS Full Width?	N/A
N/A	Landing Curb? (Y/N)	N/A	N/A	DWS Offset (in)	N/A
N/A	Shared Landing?	N/A			
N/A	Gutter Ponding?	N/A	N/A	Gutter Slope (%)	N/A
N/A	Gutter Lip Ht (in)	N/A	N/A	Gutter X Slope (%)	N/A
N/A	Painted X Walk1?	No	N/A	Painted X Walk2?	N/A
	X Walk 1 Direction	To NE		X Walk 2 Direction	N/A
N/A	X Walk 1 Width (in)	N/A	N/A	X Walk 2 Width (in)	N/A
	X Walk 1 Slope (%)	1.5		X Walk 2 Slope (%)	N/A
	X Walk 1 X Slope (%)	2.1		X Walk 2 X Slope (%)	N/A

N/A	Ramp inside XWalk1?	N/A	N/A	Ramp inside XWalk2?	N/A
	Road Slope (%)	N/A	N/A	Clear Space?	N/A
	Road X Slope (%)	N/A	N/A	Clear Space to XWalk (in)	N/A
N/A	Any Obstructions?	N/A	N/A	Storm Grate/Utility Hazard?	N/A
	Obstruction Type			Storm Grate/Utility Type	
		N/A			N/A
			Yes	Surface Condition? (G/P)	Good

Remove & Replace Entire Ramp.
