# Access Compliance Report

## Public Rights-of-Way

### (Curb Ramps)

| Intersection ID: 47852 | Main Street: CACTUS_VALLEY_RD | Cross Street: STONE_PORCH_RD | Location: W |

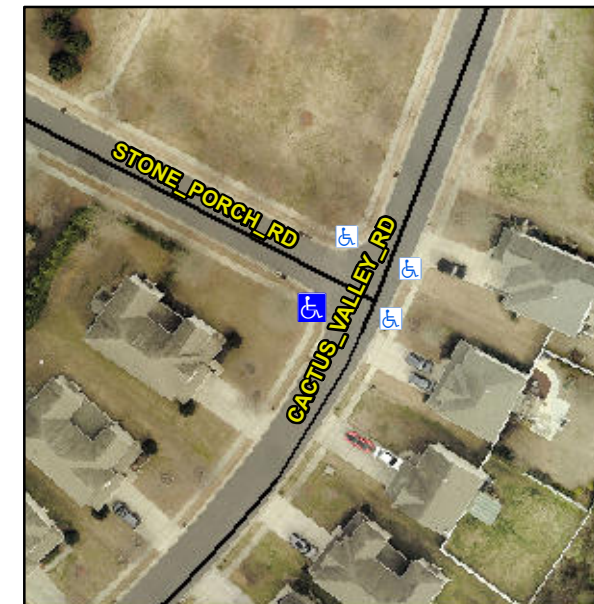
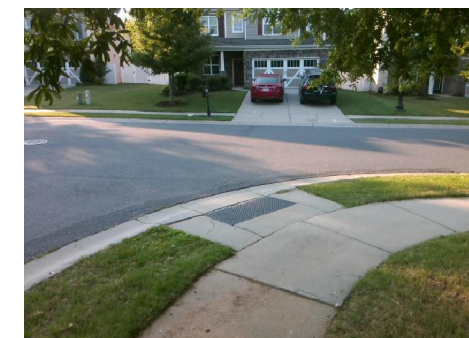
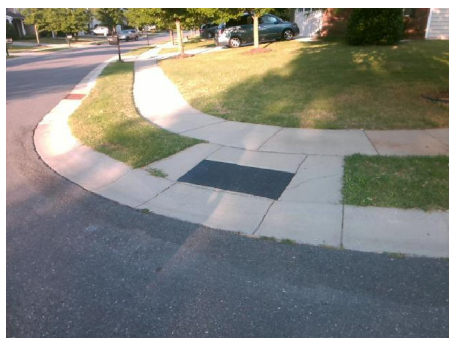
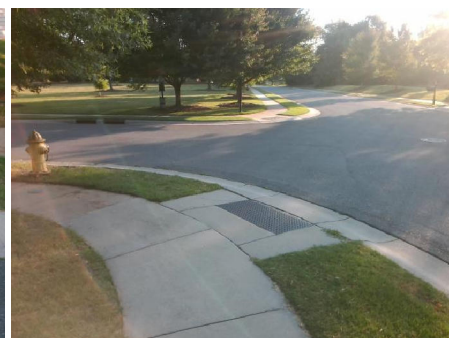
| ADA ID: 9283A3603744 | Ramp Type: PerpDiag | Initial Pass/Fail: Fail | Overall Compliance: No |

**Not Found, R304.5.1, R304.5.3**

| Compliance | Description | Data | Compliance | Description | Data |
|---|---|---|---|---|---|
| N/A | Ramp Length (in) | 47.0 | Yes | Ramp Slope (%) | 7.1 |
| No | Ramp Width (in) | 46.0 | No | Ramp XSlope (%) | 3.9 |

**Remove & Replace Curb Ramp With Two New Directional Ramps or Equivalent.**
