# Access Compliance Report

## Public Rights-of-Way

### (Curb Ramps)

Intersection ID: 53404	Main Street: MAIN_ST	Cross Street: MORGAN_PARK_DR	Location: NE
ADA ID: 9284A95B488F	Ramp Type: PerpDiag	Initial Pass/Fail: Fail	Overall Compliance: No
Severity Score: 48.75			
Codes/Mitigation Info/Possible Solution		Field Measurements/Component Compliance

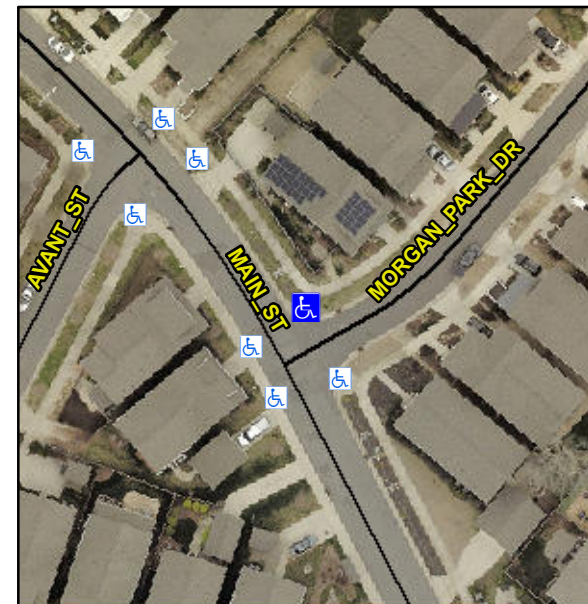
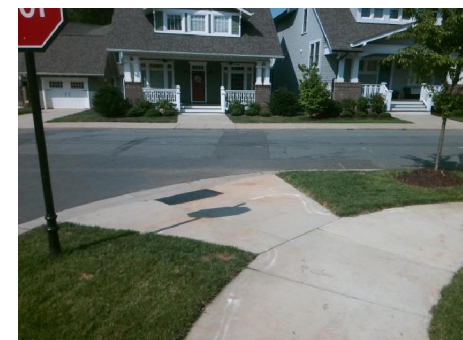
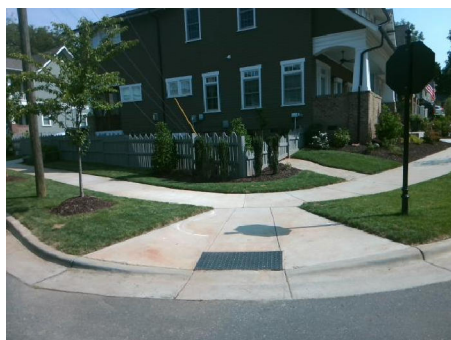
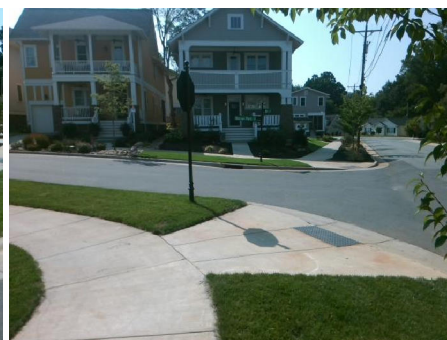
**Not Found, R304.5.1, R304.2.2, R304.5.3**

Compliance	Description	Data	Compliance	Description	Data
N/A	Ramp Length (in)	123.0	No	Ramp Slope (%)	10.2
No	Ramp Width (in)	30.0	No	Ramp XSlope (%)	3.2
N/A	Flare Type LT	N/A	N/A	Flare Type RT	N/A
N/A	Flare Slope LT (%)	N/A	N/A	Flare Slope RT (%)	N/A
N/A	Flare Traversable LT?	N/A	N/A	Flare Traversable RT?	N/A
N/A	Landing Length (in)	N/A	N/A	DWS Provided?	N/A
N/A	Landing Width (in)	N/A	N/A	DWS Contrast?	N/A
N/A	Landing Slope (%)	N/A	N/A	DWS Length (in)	N/A
N/A	Landing X Slope (%)	N/A	N/A	DWS Full Width?	N/A
N/A	Landing Curb? (Y/N)	N/A	N/A	DWS Offset (in)	N/A
N/A	Shared Landing?	N/A			
N/A	Gutter Ponding?	N/A	N/A	Gutter Slope (%)	N/A
N/A	Gutter Lip Ht (in)	N/A	N/A	Gutter X Slope (%)	N/A
N/A	Painted X Walk1?	No	N/A	Painted X Walk2?	No
	X Walk 1 Direction	To SW		X Walk 2 Direction	To SE
N/A	X Walk 1 Width (in)	N/A	N/A	X Walk 2 Width (in)	N/A
	X Walk 1 Slope (%)	7.0		X Walk 2 Slope (%)	1.1
	X Walk 1 X Slope (%)	0.7		X Walk 2 X Slope (%)	2.3

N/A	Ramp inside XWalk1?	N/A	N/A	Ramp inside XWalk2?	N/A
	Road Slope (%)	2.1	N/A	Clear Space?	N/A
	Road X Slope (%)	0.2	N/A	Clear Space to XWalk (in)	N/A
N/A	Any Obstructions?	N/A	N/A	Storm Grate/Utility Hazard?	N/A
	Obstruction Type			Storm Grate/Utility Type	
		N/A			N/A
			Yes	Surface Condition? (G/P)	Good

**Remove & Replace Curb Ramp With Two New Directional Ramps or Equivalent.**
