# Access Compliance Report

## Public Rights-of-Way

Intersection ID: 21560	Main Street: RITTENHOUSE_CR	Cross Street: SARDIS_RD_NORTH	Location: SE
ADA ID: 9286086D20A2	Ramp Type: PerpDiag	Initial Pass/Fail: Fail	Overall Compliance: No
			Severity Score: 26.25

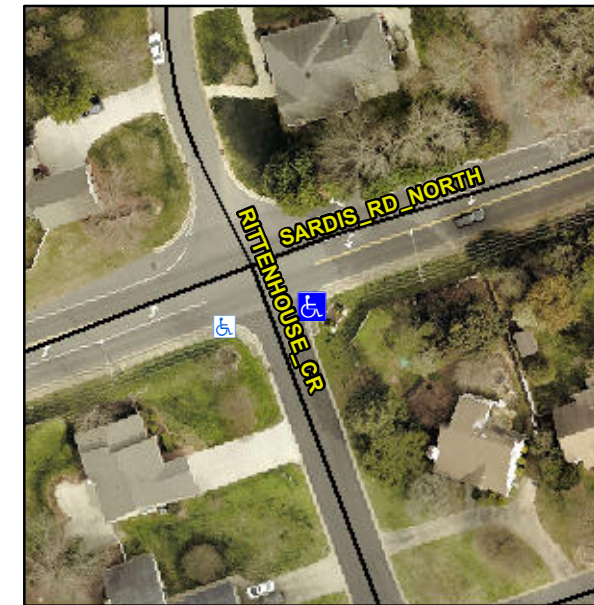
Compliance	Description	Data	Compliance	Description	Data
N/A	Ramp Length (in)	48.0	No	Ramp Slope (%)	14.4
Yes	Ramp Width (in)	48.0	No	Ramp XSlope (%)	4.4
N/A	Flare Type LT	N/A	N/A	Flare Type RT	N/A
N/A	Flare Slope LT (%)	N/A	N/A	Flare Slope RT (%)	N/A
N/A	Flare Traversable LT?	N/A	N/A	Flare Traversable RT?	N/A
N/A	Landing Length (in)	N/A	N/A	DWS Provided?	N/A
N/A	Landing Width (in)	N/A	N/A	DWS Contrast?	N/A
N/A	Landing Slope (%)	N/A	N/A	DWS Length (in)	N/A
N/A	Landing X Slope (%)	N/A	N/A	DWS Full Width?	N/A
N/A	Landing Curb? (Y/N)	N/A	N/A	DWS Offset (in)	N/A
N/A	Shared Landing?	N/A			
N/A	Gutter Ponding?	N/A	N/A	Gutter Slope (%)	N/A
N/A	Gutter Lip Ht (in)	N/A	N/A	Gutter X Slope (%)	N/A
N/A	Painted X Walk1?	No	N/A	Painted X Walk2?	No
	X Walk 1 Direction	To N		X Walk 2 Direction	To W
N/A	X Walk 1 Width (in)	N/A	N/A	X Walk 2 Width (in)	N/A
	X Walk 1 Slope (%)	4.2		X Walk 2 Slope (%)	0.7
	X Walk 1 X Slope (%)	2.8		X Walk 2 X Slope (%)	2.2

N/A	Ramp inside XWalk1?	N/A	N/A	Ramp inside XWalk2?	N/A
	Road Slope (%)	1.3	N/A	Clear Space?	N/A
	Road X Slope (%)	4.8	N/A	Clear Space to XWalk (in)	N/A
N/A	Any Obstructions?	N/A	N/A	Storm Grate/Utility Hazard?	N/A
	Obstruction Type			Storm Grate/Utility Type	
		N/A			N/A
			Yes	Surface Condition? (G/P)	Good

**Remove & Replace Curb Ramp With Two New Directional Ramps or Equivalent.**

**R304.2.2, R304.5.3**
