# Access Compliance Report

## Public Rights-of-Way

### (Curb Ramps)

Intersection ID: 18956	Main Street: N_I-77_EXIT_5_RA	Cross Street: TYVOLA_RD	Location:	N
ADA ID: 92861C44A2D1	Ramp Type: Perp	Initial Pass/Fail: Fail	Overall Compliance: No	Severity Score: 22.5
Codes/Mitigation Info/Possible Solution		Field Measurements/Component Compliance

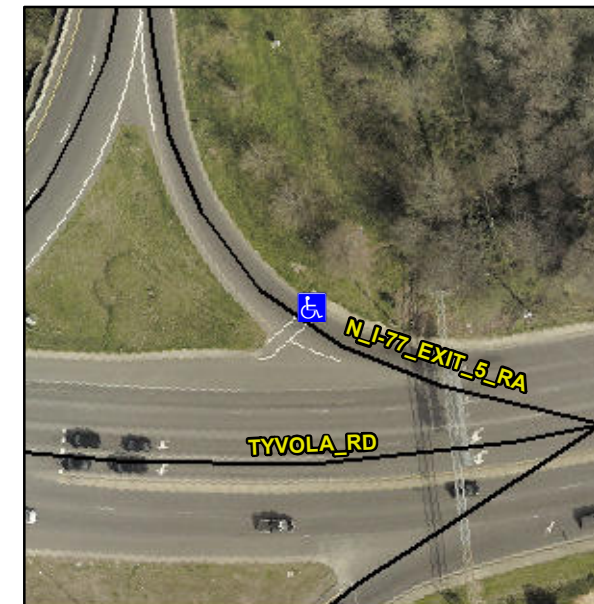
**Not Found, R304.5.1, R304.2.2**

Compliance	Description	Data	Compliance	Description	Data
N/A	Ramp Length (in)	60.0	No	Ramp Slope (%)	11.3
No	Ramp Width (in)	40.5	Yes	Ramp XSlope (%)	2.1
N/A	Flare Type LT	N/A	N/A	Flare Type RT	N/A
N/A	Flare Slope LT (%)	N/A	N/A	Flare Slope RT (%)	N/A
N/A	Flare Traversable LT?	N/A	N/A	Flare Traversable RT?	N/A
N/A	Landing Length (in)	N/A	N/A	DWS Provided?	N/A
N/A	Landing Width (in)	N/A	N/A	DWS Contrast?	N/A
N/A	Landing Slope (%)	N/A	N/A	DWS Length (in)	N/A
N/A	Landing X Slope (%)	N/A	N/A	DWS Full Width?	N/A
N/A	Landing Curb? (Y/N)	N/A	N/A	DWS Offset (in)	N/A
N/A	Shared Landing?	N/A			
N/A	Gutter Ponding?	N/A	N/A	Gutter Slope (%)	N/A
N/A	Gutter Lip Ht (in)	N/A	N/A	Gutter X Slope (%)	N/A
N/A	Painted X Walk1?	Yes	N/A	Painted X Walk2?	N/A
	X Walk 1 Direction	To SW		X Walk 2 Direction	N/A
N/A	X Walk 1 Width (in)	74.0	N/A	X Walk 2 Width (in)	N/A
	X Walk 1 Slope (%)	1.8		X Walk 2 Slope (%)	N/A
	X Walk 1 X Slope (%)	2.6		X Walk 2 X Slope (%)	N/A

N/A	Ramp inside XWalk1?	Yes	N/A	Ramp inside XWalk2?	N/A
	Road Slope (%)	N/A	N/A	Clear Space?	N/A
	Road X Slope (%)	N/A	N/A	Clear Space to XWalk (in)	N/A
N/A	Any Obstructions?	N/A	N/A	Storm Grate/Utility Hazard?	N/A
	Obstruction Type			Storm Grate/Utility Type	
		N/A			N/A
			Yes	Surface Condition? (G/P)	Good

**Remove & Replace Entire Ramp.**
