# Access Compliance Report

## Public Rights-of-Way

### (Curb Ramps)

Intersection ID: 43765	Main Street: HELENS_LN	Cross Street: EASTFIELD_RD	Location: SE
ADA ID: 92B1FBD45439	Ramp Type: Perp	Initial Pass/Fail: Fail	Overall Compliance: No
		Severity Score: 35

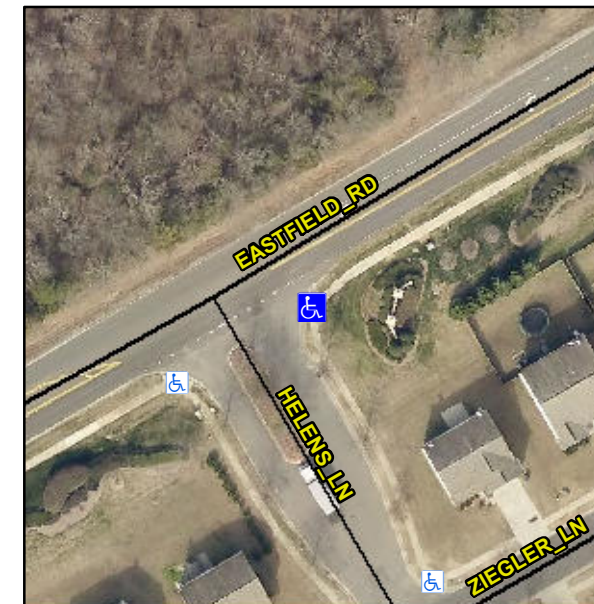
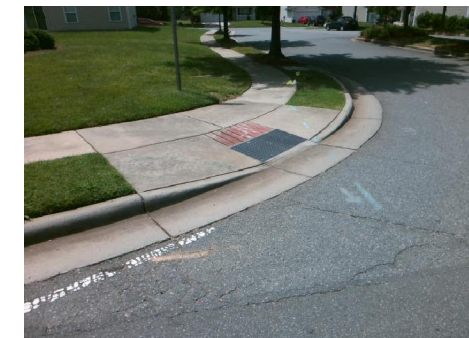
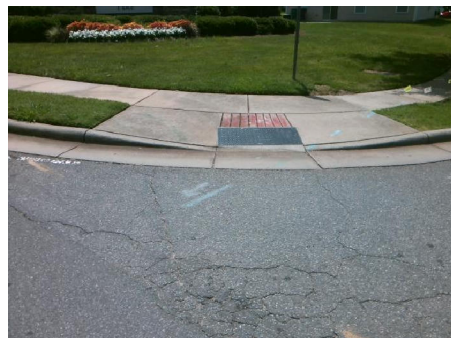
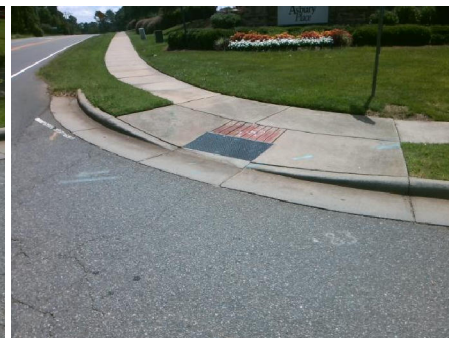
Compliance	Description	Data	Compliance	Description	Data
N/A	Ramp Length (in)	48.0	No	Ramp Slope (%)	12.3
No	Ramp Width (in)	40.0	No	Ramp XSlope (%)	3.2
N/A	Flare Type LT	N/A	N/A	Flare Type RT	N/A
N/A	Flare Slope LT (%)	N/A	N/A	Flare Slope RT (%)	N/A
N/A	Flare Traversable LT?	N/A	N/A	Flare Traversable RT?	N/A
N/A	Landing Length (in)	N/A	N/A	DWS Provided?	N/A
N/A	Landing Width (in)	N/A	N/A	DWS Contrast?	N/A
N/A	Landing Slope (%)	N/A	N/A	DWS Length (in)	N/A
N/A	Landing X Slope (%)	N/A	N/A	DWS Full Width?	N/A
N/A	Landing Curb? (Y/N)	N/A	N/A	DWS Offset (in)	N/A
N/A	Shared Landing?	N/A			
N/A	Gutter Ponding?	N/A	N/A	Gutter Slope (%)	N/A
N/A	Gutter Lip Ht (in)	N/A	N/A	Gutter X Slope (%)	N/A
N/A	Painted X Walk1?	No	N/A	Painted X Walk2?	N/A
	X Walk 1 Direction	To SW		X Walk 2 Direction	N/A
N/A	X Walk 1 Width (in)	N/A	N/A	X Walk 2 Width (in)	N/A
	X Walk 1 Slope (%)	3.3		X Walk 2 Slope (%)	N/A
	X Walk 1 X Slope (%)	3.0		X Walk 2 X Slope (%)	N/A

N/A	Ramp inside XWalk1?	N/A	N/A	Ramp inside XWalk2?	N/A
	Road Slope (%)	N/A	N/A	Clear Space?	N/A
	Road X Slope (%)	N/A	N/A	Clear Space to XWalk (in)	N/A
N/A	Any Obstructions?	N/A	N/A	Storm Grate/Utility Hazard?	N/A
	Obstruction Type			Storm Grate/Utility Type	
		N/A			N/A
			Yes	Surface Condition? (G/P)	Good

**Remove & Replace Entire Ramp.**

**R304.5.1, R304.2.2, R304.5.3**
