# Access Compliance Report

## Public Rights-of-Way (Curb Ramps)

| Intersection ID: 27563 | Main Street: BALLANTYNE_FOREST_DR | Cross Street: LEDERER_AV | Location: SW |
| ADA ID: 92C2E3E6EF45 | Ramp Type: Perp | Initial Pass/Fail: Fail | Overall Compliance: No |

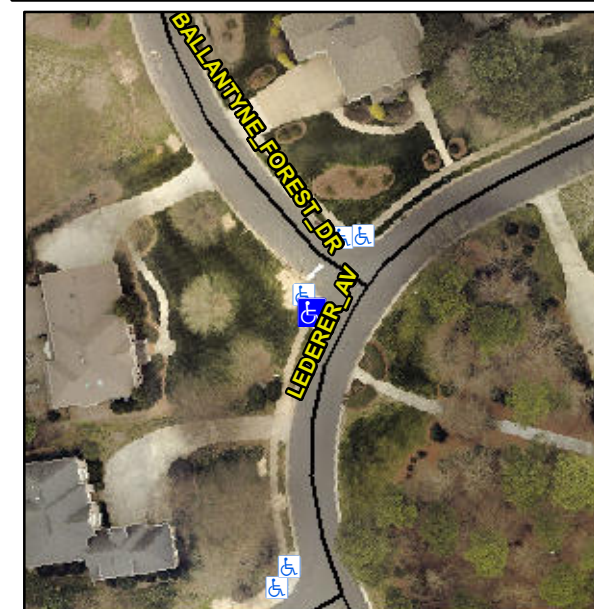
**Not Found, R304.5.1, R304.2.2**

| Compliance | Description | Data | Compliance | Description | Data |
|---|---|---|---|---|---|
| N/A | Ramp Length (in) | 46.0 | No | Ramp Slope (%) | 8.4 |
| No | Ramp Width (in) | 42.0 | Yes | Ramp XSlope (%) | 0.5 |

**Remove & Replace Entire Ramp.**

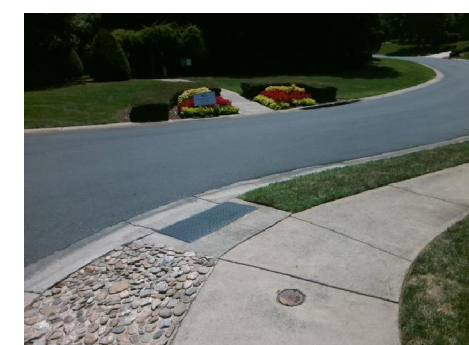
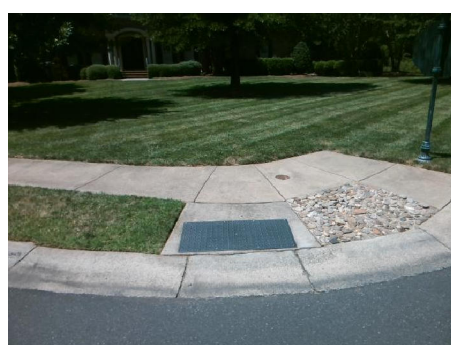
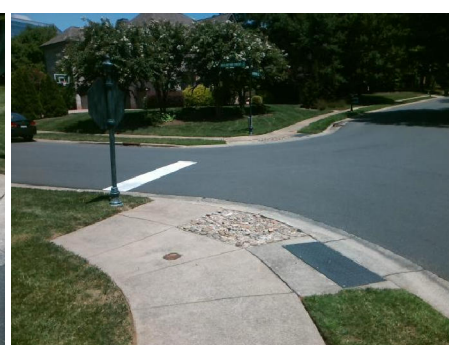
| Compliance | Description | Data | Compliance | Description | Data |
|---|---|---|---|---|---|
| | | | Yes | Surface Condition? (G/P) | Good |
