## Access Compliance Report Public Rights-of-Way (Curb Ramps)

Intersection ID: 12912	Main Street: ENFIELD_RD			Cross Street: SUDBURY_RD				Location:	SE
ADA ID: 92C652C10F6D	Ramp Type: Perp			Initial Pass/Fail: Fail Overall Compliance			nce: N	o Severity Score:	10
Codes/Mitigation Info/Possible Solution				Field Measurements/Component Compliance					
		Possible Solutions:					Compliance Description		Data
	The second	Remove & Replace Entire	Ramp.	N/A	Ramp Length (in)	48.0	Yes	Ramp Slope (%)	6.3
WE IN IN	and they	······		No	Ramp Width (in)	45.0	No	Ramp XSlope (%)	4.8
Ford I S				N/A	Flare Type LT	N/A	N/A	Flare Type RT	N/A
a Constant of the	Red The			N/A	Flare Slope LT (%)	N/A	N/A	Flare Slope RT (%)	N/A
	Es warman and a			N/A	Flare Traversable LT?	N/A	N/A	Flare Traversable RT?	N/A
				N/A	Landing Length (in)	N/A	N/A	DWS Provided?	N/A
C ENHELD	RD	Surveyor Notes:		N/A	Landing Width (in)	N/A	N/A	DWS Contrast?	N/A
	19	N/A		N/A	Landing Slope (%)	N/A	N/A	DWS Length (in)	N/A

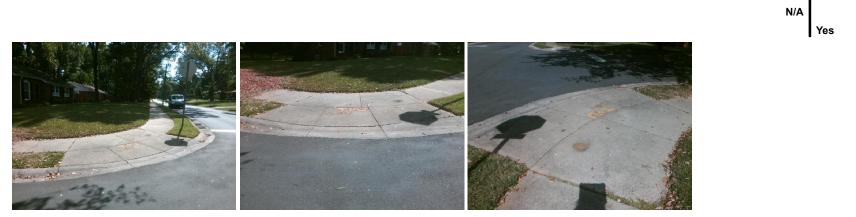
A Stranger			N/A	Landing X Slope (%)	N/A	N/A	DWS Full Width?	N/A
6	A BRANES			N/A	Landing Curb? (Y/N)	N/A	N/A	DWS Offset (in)	N/A
	the state of the s			N/A	Shared Landing?	N/A			
		PROW/ADA:		N/A	Gutter Ponding?	N/A	N/A	Gutter Slope (%)	N/A
Street 1 Marsh		Not Found, R304.5.1, R30	4.5.3	N/A	Gutter Lip Ht (in)	N/A	N/A	Gutter X Slope (%)	N/A
1 A A M	Wish Mars	,,		N/A	Painted X Walk1?	No	N/A	Painted X Walk2?	N/A
E 11000	TAL STREET				X Walk 1 Direction	To N		X Walk 2 Direction	N/A
	1			N/A	X Walk 1 Width (in)	N/A	N/A	X Walk 2 Width (in)	N/A
Street 1 Name	ENFIELD RD	-			X Walk 1 Slope (%)	1.8		X Walk 2 Slope (%)	N/A
Stop Condition-Street 2	StopSign				X Walk 1 X Slope (%)	5.5		X Walk 2 X Slope (%)	N/A
Street 2 Name	N/A			N/A	Ramp inside XWalk1?	N/A	N/A	Ramp inside XWalk2?	N/A
Stop Condition-Street 1	N/A				Road Slope (%)	N/A	N/A	Clear Space?	N/A
					Road X Slope (%)	N/A	N/A	Clear Space to XWalk (in)	N/A

N/A	Any Obstructions?	N/A	N/A	Storm Grate/Utility Hazard?	N/A
		Total Cost:	\$ 1850.00		Obstruction Type			Storm Grate/Utility Type	
						N/A			N/A
