Access Compliance Report

Public Rights-of-Way

(Curb Ramps)

Intersection ID: 11873	Main Street: PLOTT_RD	Cross Street: VAN_DE_ROHE_DR	Location: NE
ADA ID: 92D63D85A8E6	Ramp Type: Directional1	Initial Pass/Fail: Fail	Overall Compliance: No
Codes/Mitigation Info/Possible Solution		Field Measurements/Component Compliance	
Severity Score: 21.25

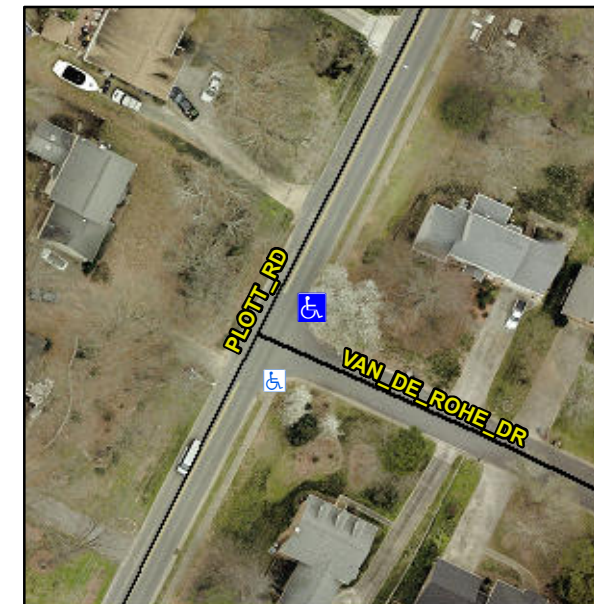
CURB GAP 2.5"

R304.5.1, R304.2.2

Compliance	Description	Data	Compliance	Description	Data
N/A	Ramp Length (in)	14.0	N/A	Grade Break?	N/A
No	Ramp Width (in)	36.0	N/A	Grade Break Slope (%)	0.0
No	Ramp Slope (%)	11.3	N/A	Grade Break XSlope (%)	0.0
Yes	Ramp XSlope (%)	0.1			
N/A	Flare Type LT	N/A	N/A	Flare Type RT	N/A
N/A	Flare Slope LT (%)	N/A	N/A	Flare Slope RT (%)	0.0
N/A	Flare Traversable LT?	N/A	N/A	Flare Traversable RT?	N/A
N/A	Landing Length (in)	0.0	N/A	DWS Provided?	N/A
N/A	Landing Width (in)	0.0	N/A	DWS Contrast?	N/A
N/A	Landing Slope (%)	0.0	N/A	DWS Length (in)	N/A
N/A	Landing X Slope (%)	0.0	N/A	DWS Full Width?	N/A
N/A	Landing Curb? (Y/N)	N/A	N/A	DWS Offset LT (in)	N/A
N/A	Shared Landing?	N/A	N/A	DWS Offset RT (in)	N/A
N/A	Gutter Ponding?	0.0	N/A	Gutter Slope (%)	N/A
N/A	Gutter Lip Ht (in)	1.25	N/A	Gutter X Slope (%)	N/A
N/A	Painted X Walk1?	No		Road Slope (%)	2.2
	X Walk 1 Direction	To S		Road X Slope (%)	6.1
	X Walk 1 Width (in)	N/A		Clear Space?	N/A

X Walk 1 Slope (%)	2.2	N/A	Clear Space to XWalk (in)	N/A
	X Walk 1 X Slope (%)	6.1	N/A	Storm Grate/Utility Hazard?	N/A
N/A	Ramp inside XWalk1?	N/A		Storm Grate/Utility Type	
N/A	Any Obstructions?	N/A			N/A
	Obstruction Type		Yes	Surface Condition? (G/P)	Good
			N/A	Curb Slope (%)	19.8

Remove & Replace Entire Ramp.
