Access Compliance Report

Public Rights-of-Way

(Curb Ramps)

Intersection ID: 8922	Main Street: BARRINGTON_DR	Cross Street: BRIDLEWOOD_LN	Location: SW
ADA ID: 92DF096C6E44	Ramp Type: Directional1	Initial Pass/Fail: Fail	Overall Compliance: No
		Severity Score: 25

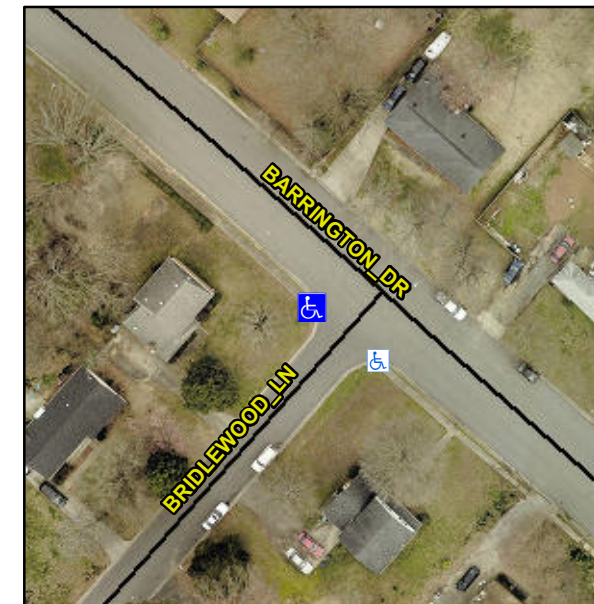
Compliance	Description	Data	Compliance	Description	Data
N/A	Ramp Length (in)	52.0	N/A	Grade Break?	N/A
Yes	Ramp Width (in)	48.0	N/A	Grade Break Slope (%)	0.0
No	Ramp Slope (%)	13.2	N/A	Grade Break XSlope (%)	0.0
Yes	Ramp XSlope (%)	0.8			
N/A	Flare Type LT	N/A	N/A	Flare Type RT	N/A
N/A	Flare Slope LT (%)	N/A	N/A	Flare Slope RT (%)	0.0
N/A	Flare Traversable LT?	N/A	N/A	Flare Traversable RT?	N/A
N/A	Landing Length (in)	0.0	N/A	DWS Provided?	N/A
N/A	Landing Width (in)	0.0	N/A	DWS Contrast?	N/A
N/A	Landing Slope (%)	0.0	N/A	DWS Length (in)	N/A
N/A	Landing X Slope (%)	0.0	N/A	DWS Full Width?	N/A
N/A	Landing Curb? (Y/N)	N/A	N/A	DWS Offset LT (in)	N/A
N/A	Shared Landing?	N/A	N/A	DWS Offset RT (in)	N/A
N/A	Gutter Ponding?	0.0	N/A	Gutter Slope (%)	N/A
N/A	Gutter Lip Ht (in)	0.5	N/A	Gutter X Slope (%)	N/A
N/A	Painted X Walk1?	No		Road Slope (%)	3.5
	X Walk 1 Direction	To SE		Road X Slope (%)	2.0
	X Walk 1 Width (in)	N/A		Clear Space?	N/A

X Walk 1 Slope (%)	3.5	N/A	Clear Space to XWalk (in)	N/A
	X Walk 1 X Slope (%)	2.0	N/A	Storm Grate/Utility Hazard?	N/A
N/A	Ramp inside XWalk1?	N/A		Storm Grate/Utility Type	
N/A	Any Obstructions?	N/A			N/A
	Obstruction Type		Yes	Surface Condition? (G/P)	Good
			N/A	Curb Slope (%)	23.0

Remove & Replace Entire Ramp.

R304.2.2
