# Access Compliance Report

## Public Rights-of-Way

Intersection ID: 24614	Main Street: BECKMORE_PL	Cross Street: PINEVILLE-MATTHEWS_RD	Location:	N
ADA ID: 92E4AAAB70BD	Ramp Type: Perp	Initial Pass/Fail: Fail	Overall Compliance: No	Severity Score: 12.5
Codes/Mitigation Info/Possible Solution		Field Measurements/Component Compliance

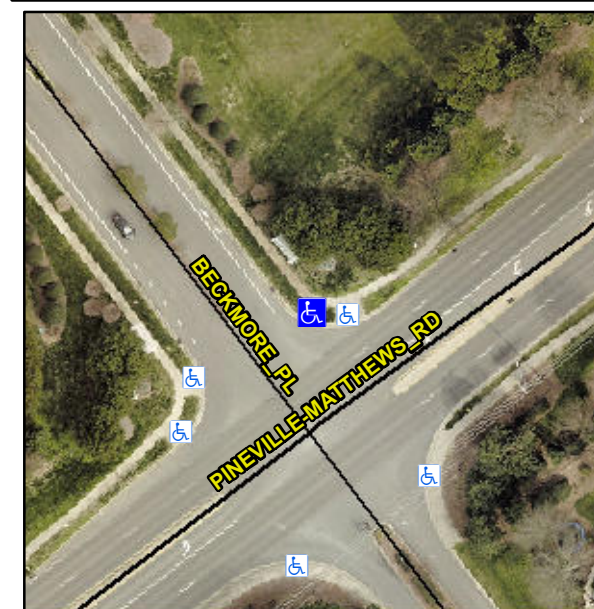
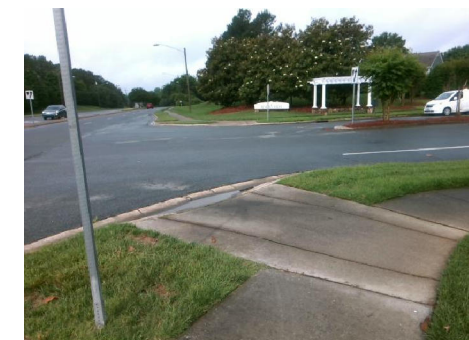
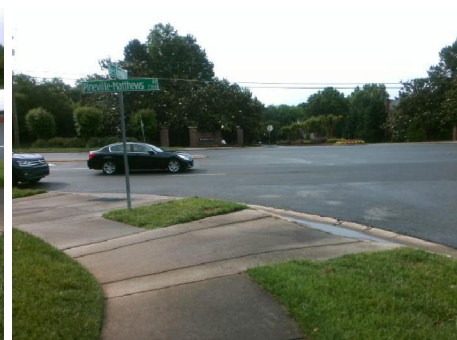
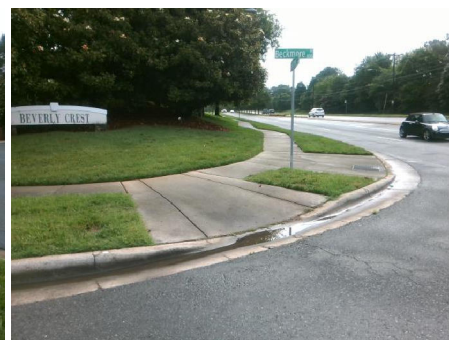
Compliance	Description	Data	Compliance	Description	Data
N/A	Ramp Length (in)	96.0	No	Ramp Slope (%)	9.3
Yes	Ramp Width (in)	60.0	Yes	Ramp XSlope (%)	0.4
N/A	Flare Type LT	N/A	N/A	Flare Type RT	N/A
N/A	Flare Slope LT (%)	N/A	N/A	Flare Slope RT (%)	N/A
N/A	Flare Traversable LT?	N/A	N/A	Flare Traversable RT?	N/A
N/A	Landing Length (in)	N/A	N/A	DWS Provided?	N/A
N/A	Landing Width (in)	N/A	N/A	DWS Contrast?	N/A
N/A	Landing Slope (%)	N/A	N/A	DWS Length (in)	N/A
N/A	Landing X Slope (%)	N/A	N/A	DWS Full Width?	N/A
N/A	Landing Curb? (Y/N)	N/A	N/A	DWS Offset (in)	N/A
N/A	Shared Landing?	N/A			
N/A	Gutter Ponding?	N/A	N/A	Gutter Slope (%)	N/A
N/A	Gutter Lip Ht (in)	N/A	N/A	Gutter X Slope (%)	N/A
N/A	Painted X Walk1?	No	N/A	Painted X Walk2?	N/A
	X Walk 1 Direction	To W		X Walk 2 Direction	N/A
N/A	X Walk 1 Width (in)	N/A	N/A	X Walk 2 Width (in)	N/A
	X Walk 1 Slope (%)	1.6		X Walk 2 Slope (%)	N/A
	X Walk 1 X Slope (%)	1.2		X Walk 2 X Slope (%)	N/A

**Remove & Replace Entire Ramp.**
