Access Compliance Report

Public Rights-of-Way

(Curb Ramps)

| Intersection ID: 10276 | Main Street: ASHLEY_RD | Cross Street: TUCKASEEGEE_RD | Location: NE |

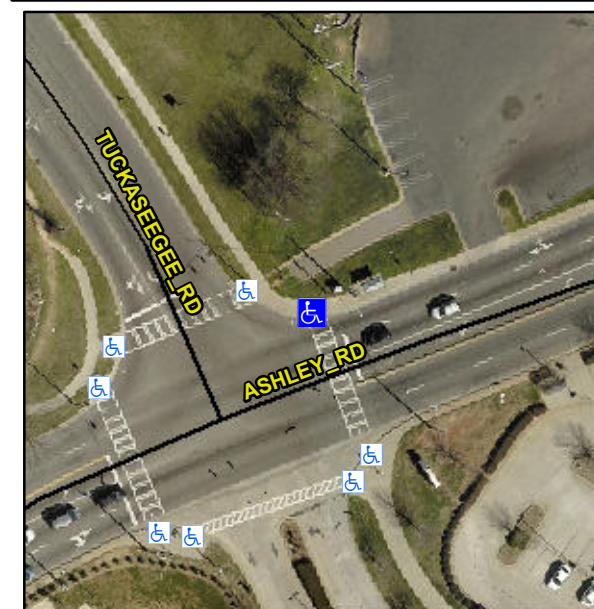
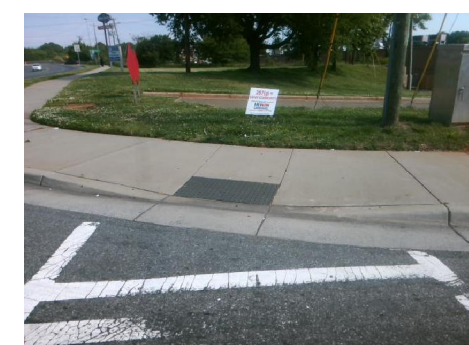
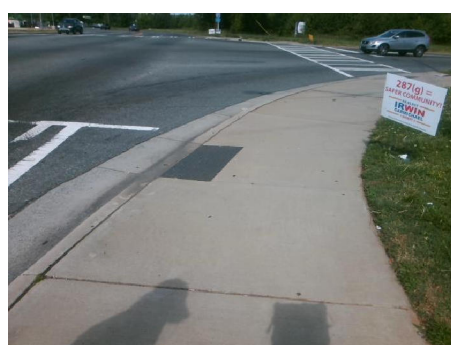
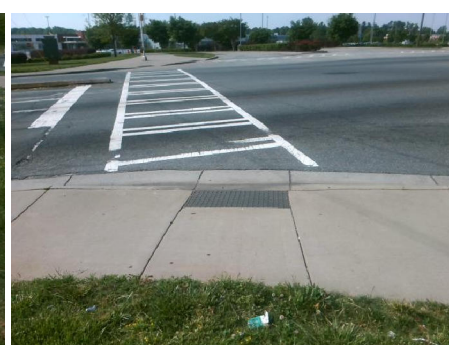
| ADA ID: 9304D8A40BCB | Ramp Type: Perp | Initial Pass/Fail: Fail | Overall Compliance: No |
| Severity Score: 13.75 | | | |

R304.2.2

| Compliance | Description | Data | Compliance | Description | Data |
|---|---|---|---|---|---|
| N/A | Ramp Length (in) | 83.0 | No | Ramp Slope (%) | 8.8 |

Remove & Replace Entire Ramp.
