## **Access Compliance Report Public Rights-of-Way** (Curb Ramps)

Intersection ID: 10026324 Main Street: FAIRVIEW RD **Cross Street: N/A** Location: SE ADA ID: 93098896E306 Ramp Type: PerpDiag Initial Pass/Fail: Fail **Overall Compliance: No** Severity Score: 33.75

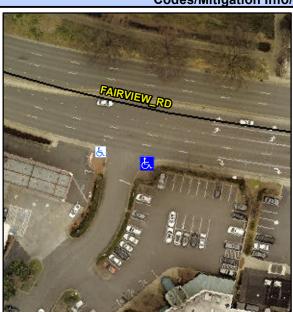
Compliance Description Data Cor				Diance Description	Data
N/A	Ramp Length (in)	46.0	No	Ramp Slope (%)	13.3
No No	Ramp Width (in)	36.0	Yes	Ramp XSlope (%)	0.6
N/A	Flare Type LT	N/A	N/A	Flare Type RT	N/A
N/A	· ·	N/A	N/A N/A	Flare Slope RT (%)	N/A N/A
	Flare Slope LT (%)		N/A N/A	, ,	
N/A	Flare Traversable LT?	N/A		Flare Traversable RT?	N/A
N/A	Landing Length (in)	N/A	N/A	DWS Provided?	N/A
N/A	Landing Width (in)	N/A	N/A	DWS Contrast?	N/A
N/A	Landing Slope (%)	N/A	N/A	DWS Length (in)	N/A
N/A	Landing X Slope (%)	N/A	N/A	DWS Full Width?	N/A
N/A	Landing Curb? (Y/N)	N/A	N/A	DWS Offset (in)	N/A
N/A	Shared Landing?	N/A			
N/A	Gutter Ponding?	N/A	N/A	Gutter Slope (%)	N/A
N/A	Gutter Lip Ht (in)	N/A	N/A	Gutter X Slope (%)	N/A
N/A	Painted X Walk1?	No	N/A	Painted X Walk2?	No
	X Walk 1 Direction	To NE		X Walk 2 Direction	To NW
N/A	X Walk 1 Width (in)	N/A	N/A	X Walk 2 Width (in)	N/A
	X Walk 1 Slope (%)	0.9		X Walk 2 Slope (%)	0.4

X Walk 1 X Slope (%)	0.9		X Walk 2 X Slope (%)	2.5
N/A	Ramp inside XWalk1?	N/A	N/A	Ramp inside XWalk2?	N/A
	Road Slope (%)	0.2	N/A	Clear Space?	N/A
	Road X Slope (%)	0.6	N/A	Clear Space to XWalk (in)	N/A
N/A	Any Obstructions?	N/A	N/A	Storm Grate/Utility Hazard?	N/A
	Obstruction Type			Storm Grate/Utility Type	
		N/A			N/A
			Yes	Surface Condition? (G/P)	Good
45000	OL		•	, ,

Possible Solutions: **Remove & Replace Curb Ramp With** Two New Directional Ramps or Equivalent. Surveyor Notes: N/A PROW/ADA: Not Found, R304.5.1, R304.2.2
