Access Compliance Report

Public Rights-of-Way

(Curb Ramps)

Intersection ID: 53088	Main Street: KENMERE_LN	Cross Street: DEERFIELD_MANOR_DR	Location: NE
ADA ID: 9313ABF49948	Ramp Type: Perp	Initial Pass/Fail: Fail	Overall Compliance: No
Severity Score: 12.5			
Codes/Mitigation Info/Possible Solution		Field Measurements/Component Compliance

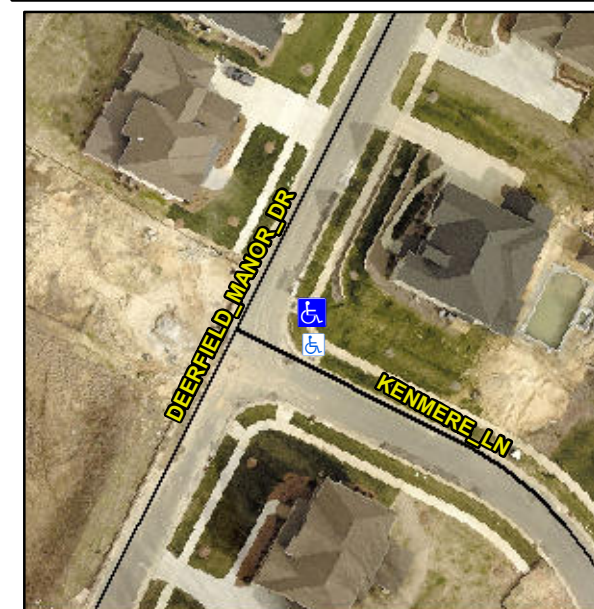
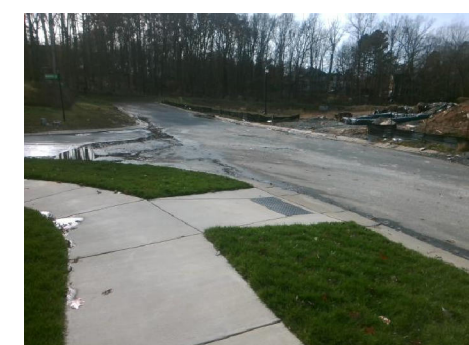
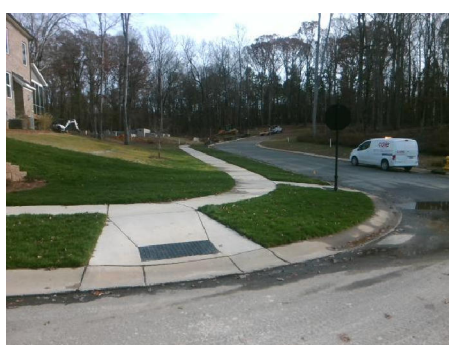
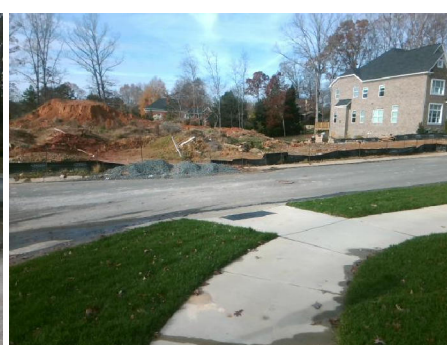
Compliance	Description	Data	Compliance	Description	Data
N/A	Ramp Length (in)	100.0	No	Ramp Slope (%)	11.6
Yes	Ramp Width (in)	48.0	Yes	Ramp XSlope (%)	0.2
N/A	Flare Type LT	N/A	N/A	Flare Type RT	N/A
N/A	Flare Slope LT (%)	N/A	N/A	Flare Slope RT (%)	N/A
N/A	Flare Traversable LT?	N/A	N/A	Flare Traversable RT?	N/A
N/A	Landing Length (in)	N/A	N/A	DWS Provided?	N/A
N/A	Landing Width (in)	N/A	N/A	DWS Contrast?	N/A
N/A	Landing Slope (%)	N/A	N/A	DWS Length (in)	N/A
N/A	Landing X Slope (%)	N/A	N/A	DWS Full Width?	N/A
N/A	Landing Curb? (Y/N)	N/A	N/A	DWS Offset (in)	N/A
N/A	Shared Landing?	N/A			
N/A	Gutter Ponding?	N/A	N/A	Gutter Slope (%)	N/A
N/A	Gutter Lip Ht (in)	N/A	N/A	Gutter X Slope (%)	N/A
N/A	Painted X Walk1?	No	N/A	Painted X Walk2?	N/A
	X Walk 1 Direction	To NW		X Walk 2 Direction	N/A
N/A	X Walk 1 Width (in)	N/A	N/A	X Walk 2 Width (in)	N/A
	X Walk 1 Slope (%)	4.4		X Walk 2 Slope (%)	N/A
	X Walk 1 X Slope (%)	2.5		X Walk 2 X Slope (%)	N/A

N/A	Ramp inside XWalk1?	N/A	N/A	Ramp inside XWalk2?	N/A
	Road Slope (%)	N/A	N/A	Clear Space?	N/A
	Road X Slope (%)	N/A	N/A	Clear Space to XWalk (in)	N/A
N/A	Any Obstructions?	N/A	N/A	Storm Grate/Utility Hazard?	N/A
	Obstruction Type			Storm Grate/Utility Type	
		N/A			N/A
		Yes		Surface Condition? (G/P)	Good

Remove & Replace Entire Ramp.
