Access Compliance Report

Public Rights-of-Way

(Curb Ramps)

| Intersection ID: 8269 | Main Street: CANDYSTICK_LN | Cross Street: CINDERELLA_RD | Location: | N |

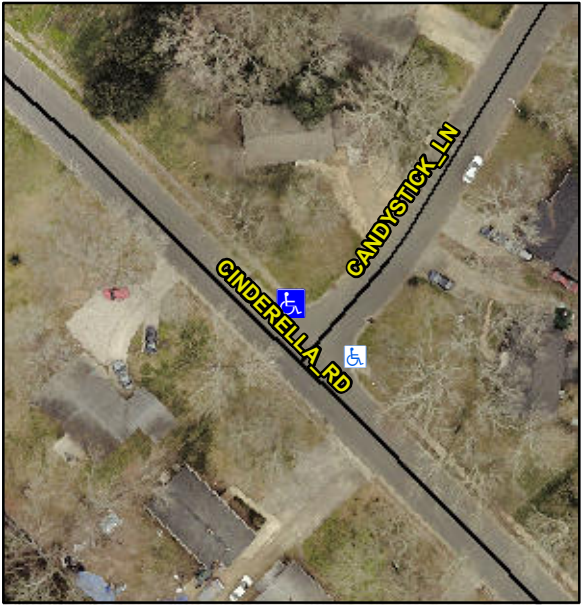
| ADA ID: 931EF2CD7EB7 | Ramp Type: Perp | Initial Pass/Fail: Fail | Overall Compliance: No | Severity Score: 1.25 |

| Codes/Mitigation Info/Possible Solution | | | Field Measurements/Component Compliance | | |
|---|--|---|---|---|---|
| <p>Surveyor Notes:</p> <p>N/A</p> <p>PROW/ADA:</p> <p>Not Found, R304.5.3</p> | | | N/A | Flare Type RT | N/A |
| | | | N/A | Gutter Lip Ht (in) | 2.0 |

| Codes/Mitigation Info/Possible Solution | | | Field Measurements/Component Compliance | | |
|---|--|---|---|---|---|
| | Possible Solutions: | | Compliance | Description | Data |
| | Remove & Replace Entire Ramp. | | Yes | Ramp Length (in) | 39.0 |
| Total Cost: | | \$ 1850.00 | | | |
