Access Compliance Report Public Rights-of-Way (Curb Ramps)

Intersection ID: 19216 Main Street: RAMA_RD Cross Street: SARDIS_RD Location: SE

ADA ID: 9321A56D5415 Ramp Type: IslandPerp Initial Pass/Fail: Fail Overall Compliance: No Severity Score: 8.75

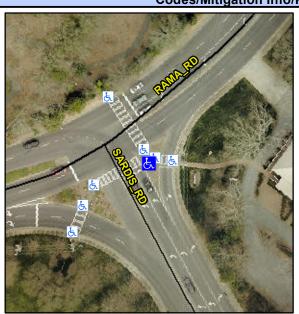
Field Measurements/Component Compliance						
Compl	liance Description	Data	Comp	liance Description	Data	
N/A	Ramp Length (in)	27.5	Yes	Ramp Slope (%)	3.9	
No	Ramp Width (in)	47.0	Yes	Ramp XSlope (%)	1.7	
N/A	Flare Type LT	N/A	N/A	Flare Type RT	N/A	
N/A	Flare Slope LT (%)	N/A	N/A	Flare Slope RT (%)	N/A	
N/A	Flare Traversable LT?	N/A	N/A	Flare Traversable RT?	N/A	
N/A	Landing Length (in)	N/A	N/A	DWS Provided?	N/A	
N/A	Landing Width (in)	N/A	N/A	DWS Contrast?	N/A	
N/A	Landing Slope (%)	N/A	N/A	DWS Length (in)	N/A	
N/A	Landing X Slope (%)	N/A	N/A	DWS Full Width?	N/A	
N/A	Landing Curb? (Y/N)	N/A	N/A	DWS Offset (in)	N/A	
N/A	Shared Landing?	N/A				
N/A	Gutter Ponding?	N/A	N/A	Gutter Slope (%)	N/A	
N/A	Gutter Lip Ht (in)	N/A	N/A	Gutter X Slope (%)	N/A	
N/A	Painted X Walk1?	Yes	N/A	Painted X Walk2?	N/A	
	X Walk 1 Direction	To SW		X Walk 2 Direction	N/A	
N/A	X Walk 1 Width (in)	105.0	N/A	X Walk 2 Width (in)	N/A	
	X Walk 1 Slope (%)	2.8		X Walk 2 Slope (%)	N/A

X Walk 1 X Slope (%)	1.1		X Walk 2 X Slope (%)	N/A	
N/A	Ramp inside XWalk1?	Yes	N/A	Ramp inside XWalk2?	N/A	
	Road Slope (%)	N/A	N/A	Clear Space?	N/A	
	Road X Slope (%)	N/A	N/A	Clear Space to XWalk (in)	N/A	
N/A	Any Obstructions?	N/A	N/A	Storm Grate/Utility Hazard?	N/A	
	Obstruction Type			Storm Grate/Utility Type		
		N/A			N/A	
			Yes	Surface Condition? (G/P)	Good

Possible Solutions:	Co
Remove & Replace Entire Ramp.	N/A
	No
	N/A
	N/A
	N/A
	N/A
Surveyor Notes:	N/A
N/A	N/A
	N/A
	N/A
	N/A
PROW/ADA:	N/A
Not Found, R304.5.1	N/A
,	N/A
	N//
	N//
